RISK WATCH

The importance of a proper lookout

At 0540 on 10 March 2012 the bulk carrier *SEAGATE* (17,590gt) and the refrigerated cargo ship *TIMOR STREAM* (9,307gt) collided in open waters, 24nm north of the Dominican Republic.

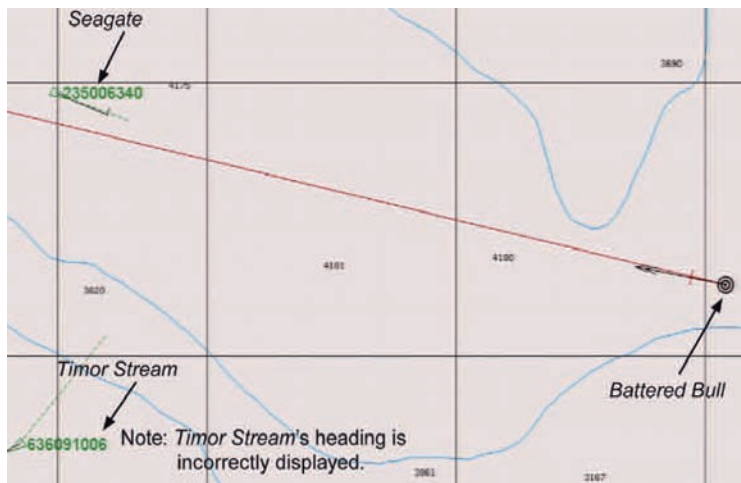
BATTERED BULL'S ECS display at 0520

12.5 knots on an almost reciprocal course to *SEAGATE*. The chief officer was on watch and had acquired both *TIMOR STREAM* and *SEAGATE* as targets using his ARPA and AIS. He identified that the two ships were on a collision course and that action was required by *SEAGATE*, the give way ship, to avoid a close quarters situation or collision. At 0532 he altered course 24° to port to avoid the developing situation.

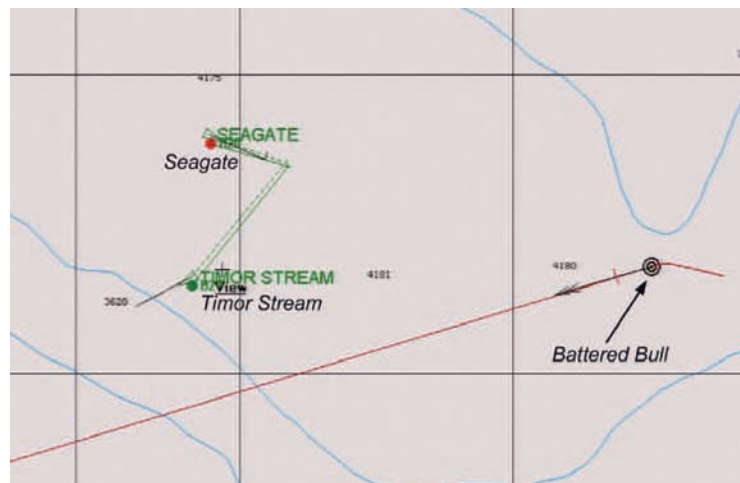
BATTERED BULL'S ECS display at 0533

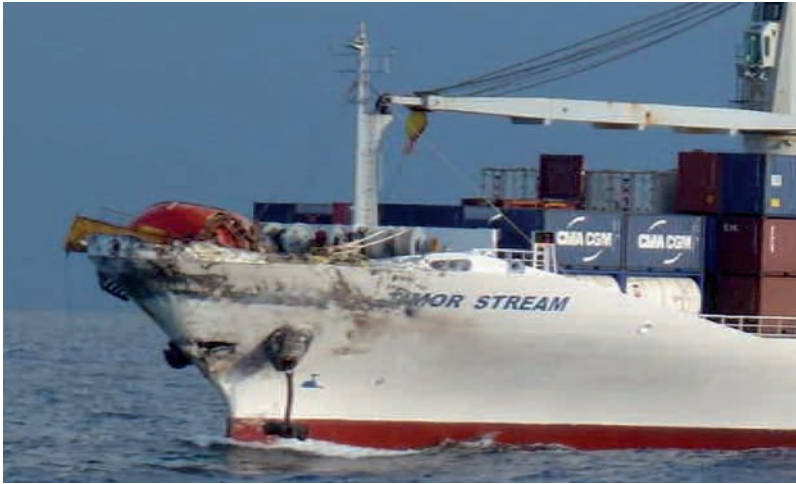
TIMOR STREAM's bow hit *SEAGATE*'s starboard quarter in the area of the accommodation block and engine room. The engine room immediately started to flood and the electrical power system failed. *SEAGATE*'s starboard life raft was destroyed and its starboard lifeboat fell onto *TIMOR STREAM*'s damaged forecastle deck.

TIMOR STREAM'S bow section – post collision

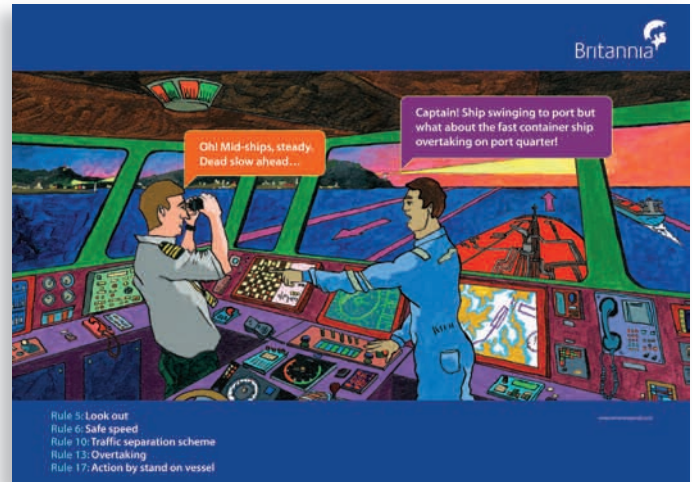
Collision regulation posters: COLREGS rules 5, 6, 10, 13 and 17

The scene played out in the poster depicts the ship at dusk in a traffic separation scheme with a bustling port on the port side. The ship is intending to cross the separation scheme and head for the anchorage in order to take on bunkers. The ship is beginning to alter course across the traffic separation scheme and is proceeding at a safe speed, with the engines on immediate notice for manoeuvring to comply with the factors for the setting of a safe speed as set out in Rule 6. All appears to be fine...

The master orders hard to port, however the cadet has observed a fast ship overtaking at high speed on the port quarter. The master retracts the helm order and reduces the engine revs to maintain steerage. The overtaking ship is obliged to keep clear under Rule 13 and as the stand-on ship the overtaken ship is required to keep her course and speed. In this case, providing the overtaken ship maintains steerage and does not alter course in front of the overtaking ship, the Rules are met.

Unfortunately accidents of this nature do occur even when the bridge team is well manned. On a positive note, the bridge team management clearly is working, as the cadet has the confidence to question the master which results in the avoidance of a serious incident.

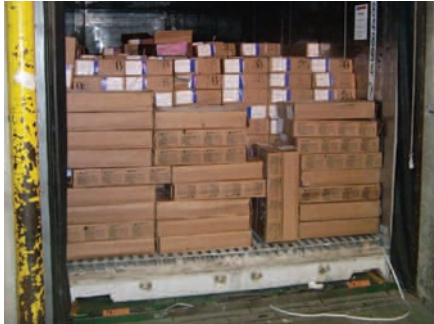
Loaded cartons inside the container

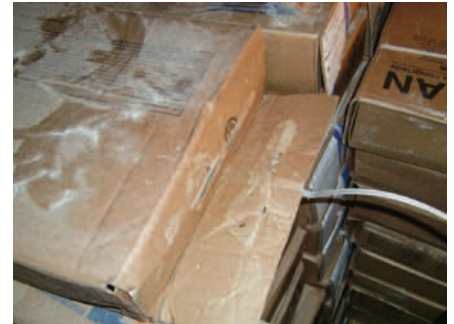
White powder on the packed cartons

These findings indicate the most likely source of the white powder could be as a result of corrosion of the aluminium materials within the reefer and the refrigeration system. The most likely cause of this is corrosive fumigants used over the period of the containers' life and a lack of necessary specialist cleaning.

Taking into consideration the information that was mentioned in the previous article and the conclusion from our appointed specialist, it would appear that the most proactive way to prevent such issues would be to regularly liaise with the shippers regarding cargoes carried and the fumigants used. The container operations department should then be able to arrange the cleaning of each reefer container with the relevant specific cleaning method and products. Refrigeration systems should be regularly and closely inspected to ensure no corrosion of the heat exchange fins has occurred in order to eliminate any possibility of corrosion inside the reefer container and the refrigeration system. This would prolong the life of the reefer container, thereby limiting the chance of any potential cargo contamination claims in the future.

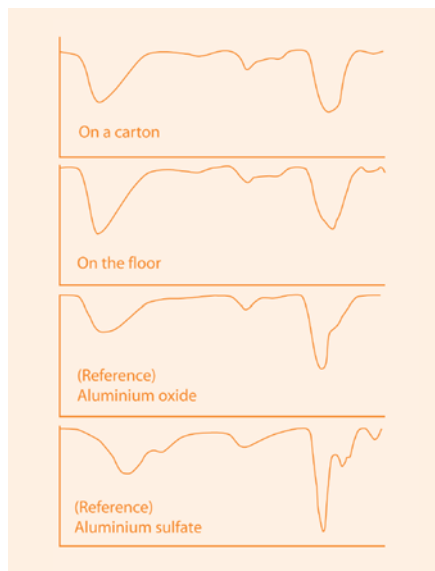
Fig.1 Infrared absorption spectrometry (FT-IR)

The samples were fragile, amorphous and their appearance was white or clear. It was found they had absorption bands between 3330 cm⁻¹ and 1090 cm⁻¹, which suggested that they were inorganic matter. The major components of the samples were aluminium, oxygen and sulphur with lesser amounts of silicon, phosphorus, calcium and chlorine.
