FATAL FALL FROM A LADDER

AN ABLE-BODIED SEAMEN (AB) ON BOARD A PRODUCT TANKER SUFFERED SEVERE INJURIES AFTER FALLING FROM A PORTABLE LADDER (FIGURE 1) WHILE CONDUCTING MAINTENANCE WORK ON THE LAUNCHING SYSTEM FOR THE SHIP'S FREE-FALL LIFEBOAT. DESPITE BEING ADMINISTERED FIRST AID IN THE SHIP'S HOSPITAL, HE TRAGICALLY DIED THREE HOURS AFTER THE INCIDENT.

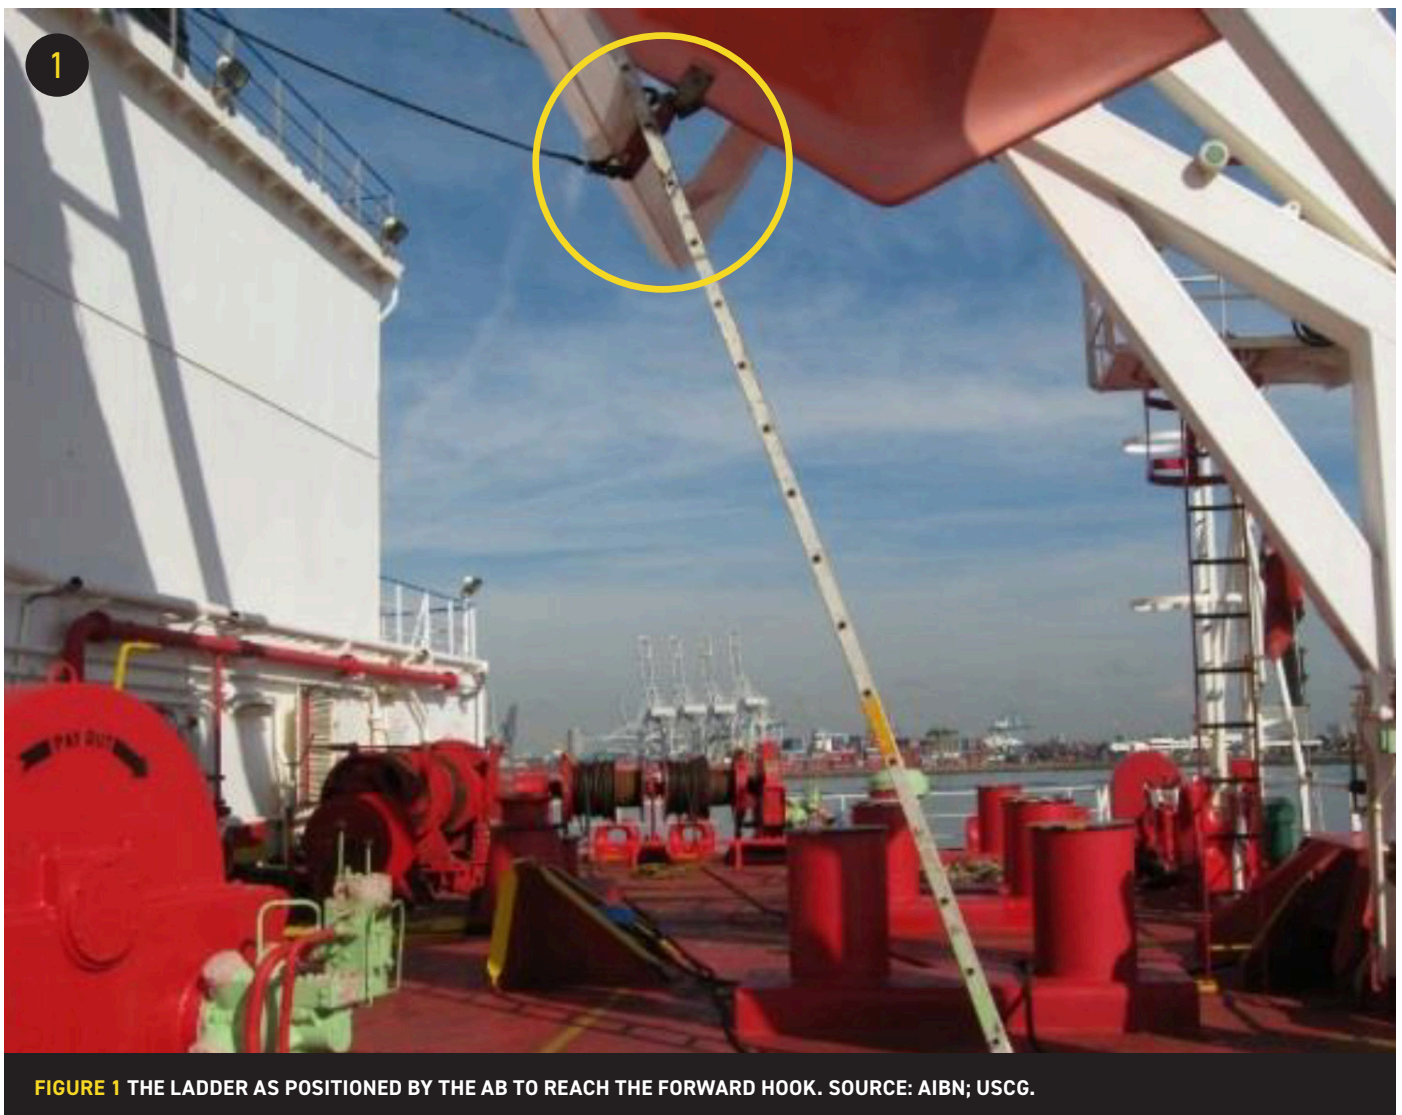
FIGURE 1 THE LADDER AS POSITIONED BY THE AB TO REACH THE FORWARD HOOK. SOURCE: AIBN; USCG.

While performing the job, the AB observed that the forward hook on the davit of the free-fall lifeboat needed lubrication with WD40 penetrating oil. Having finished the work on the turnbuckle, the AB proceeded to the paint store, where the bosun was working, and asked him to assist him with the maintenance task on the forward hook by steadying a ladder he had positioned on deck below the lifeboat to reach the hook (Figure 1 and 4).

The AB climbed up the ladder, reportedly not wearing any PPE. The bosun tried to stop him, but he nonetheless continued to assist by holding the ladder while the AB ascended. Having climbed part of the way up, the ladder suddenly slipped. The bosun was not able to hold the ladder so the AB fell and ending up lying unconscious on his back on the deck.

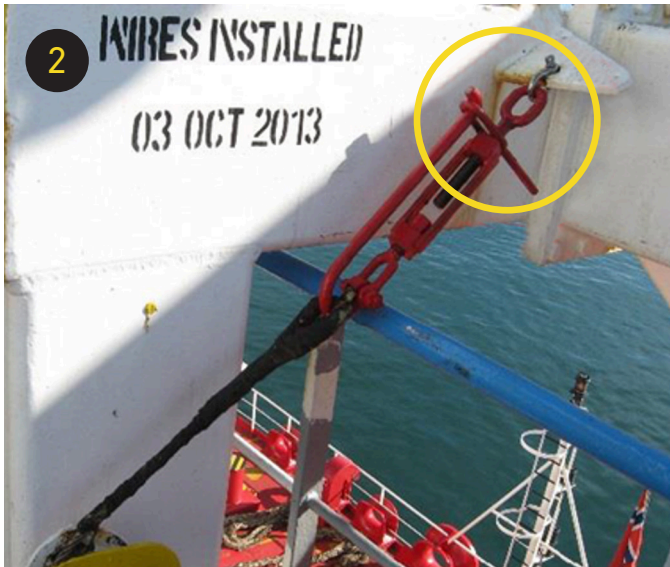
A 42,893 gt product tanker was on route from South Korea to Los Angeles, where she was due to discharge her cargo of Jet A1 fuel. As it had been announced that a USCG inspection would take place while the vessel was alongside in Los Angeles, preparations were being made during the passage. As part of these preparations it was found that a lashing turnbuckle (Figure 2) for the free-fall lifeboat was defective due to corrosion, as the securing pin was seized.

FIGURE 2 THE TURNBUCKLE AND THE PIN MARKED WITH A YELLOW CIRCLE) AFTER THE MAINTENANCE JOB HAD BEEN CARRIED OUT. SOURCE: AIBN; USCG

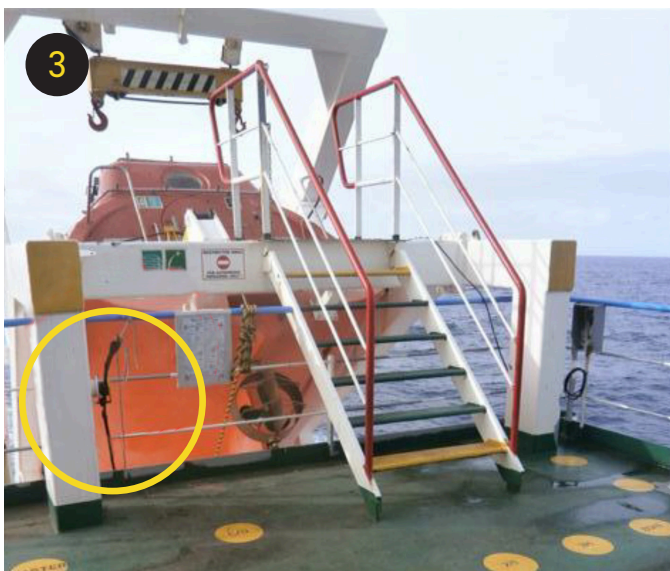
FIGURE 3 THE WORKING AREA FOR THE ORIGINALLY AGREED MAINTENANCE TASK (TURNBUCKLE MARKED WITH A YELLOW CIRCLE). SOURCE: AIBN; THOME SHIP MANAGEMENT PTE. LTD

No work permit was issued as the work was planned to take place at a height of about one metre above deck and in an area fitted with railings (Figure 3). The chief officer carried out a verbal risk assessment of the maintenance job together with the two bosuns on board. As the wind was 10m/s and the ship was rolling moderately in 2 metre waves, it was decided that no working aloft would be allowed.

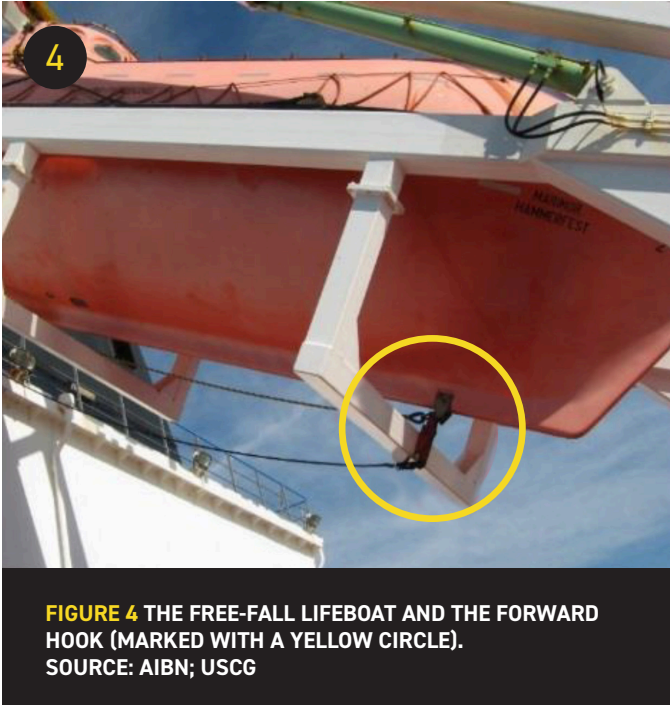
FIGURE 4 THE FREE-FALL LIFEBOAT AND THE FORWARD HOOK (MARKED WITH A YELLOW CIRCLE).
SOURCE: AIBN; USCG

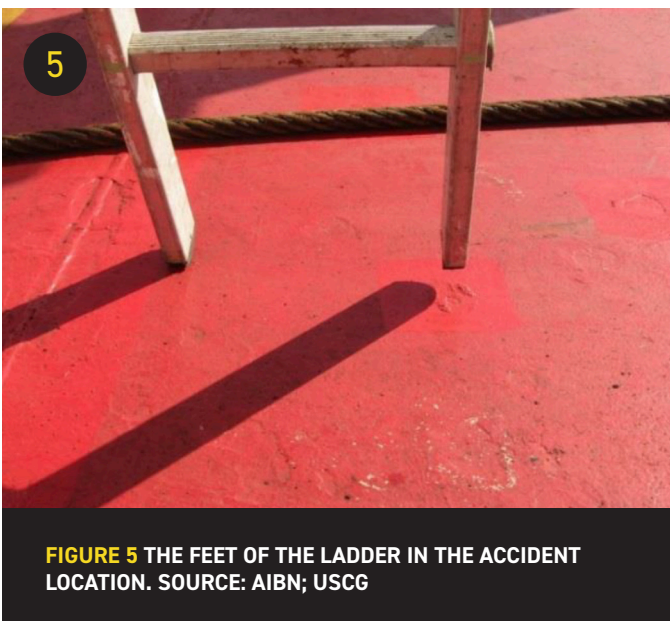
FIGURE 5 THE FEET OF THE LADDER IN THE ACCIDENT LOCATION. SOURCE: AIBN; USCG

The height from the deck to the hook was about 4.8 metres. The ladder was 5 metres in length and was equipped with rubber feet at the bottom of each leg. However, the feet were significantly worn and both were not in firm contact with the deck (Figure 5). Despite the ladder being unstable, it was not secured by any other means.

The portable ladder was not appropriate for the task being undertaken; the poor condition of the feet meant they were not both in contact with the deck. The fact that it was not safely secured would also have contributed to it being unstable and probably contributed to the ladder slipping and the AB falling off it.
