RISK WATCH

Personal injury focus: hand and finger injuries

Electronic Chart Display and Information System (ECDIS) Some lessons learned

Carriage of charcoal and other carbon cargo

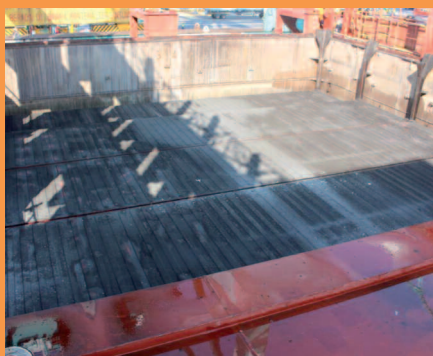
These photographs show the aftermath of a fire which originated in a 20' unit stowed towards the bottom of a cargo hold.

Upper tier of containers showing smoke damage and debris from a charcoal fire in the lower part of the hold.

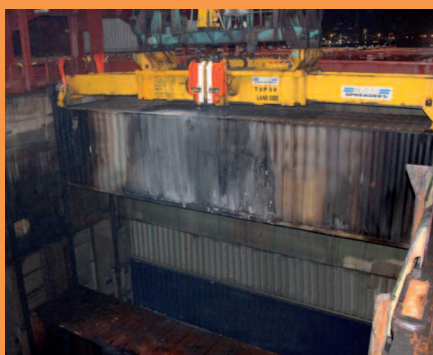
Heat damage and smoke staining to container and the hold caused by a charcoal fire.

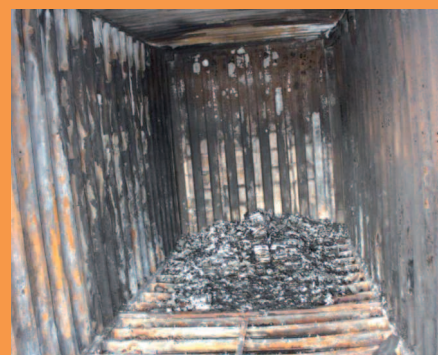
View from the aft end of the container showing that much of the plywood floor has been burnt, exposing the steel support beams.

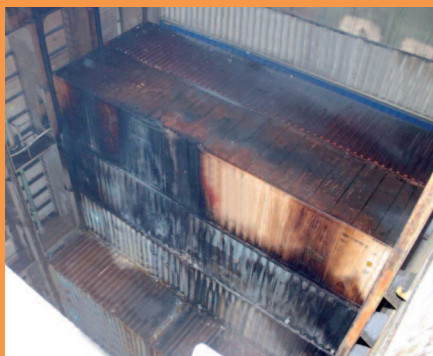
Example of severe fire damage to containers that can be caused by a charcoal fire.

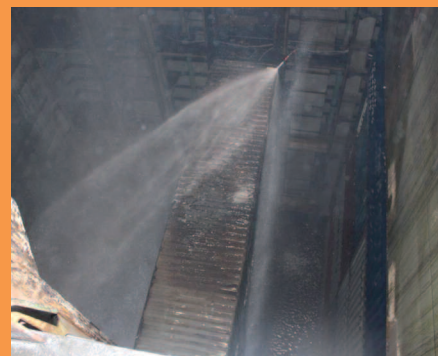
Fire hoses fixed in place to provide cooling inside and at the boundaries of the 'culprit' container of charcoal.

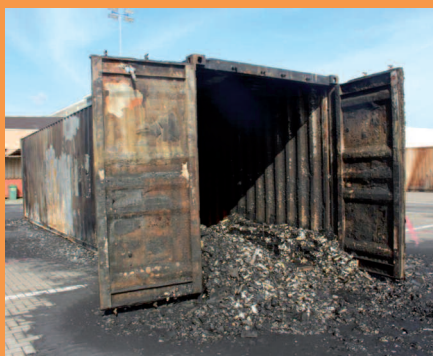
Despite the crew having followed such measures, the cargo reignited during discharge.

Discharge of a container of charcoal showing how charcoal can re-ignite with burning material falling through the floor of the container.
