INCIDENT CASE STUDY

Fatal fall from a ladder

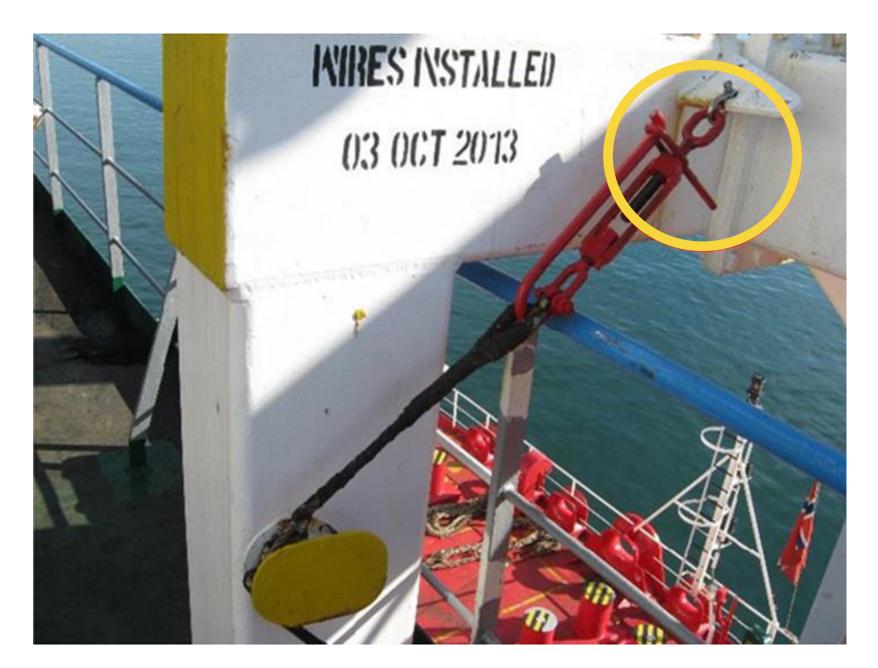
- Product tanker en route from South Korea to Los Angeles, USA
- Preparations were being made for a USCG inspection while alongside in Los Angeles
- Turnbuckle for the free-fall lifeboat found corroded, with the securing pin seized
- An AB was to carry out the work involving rust removal and painting only, as specifically instructed by the chief officer to the bosun

Turnbuckle and the pin (marked with yellow circle) after the maintenance job completed.

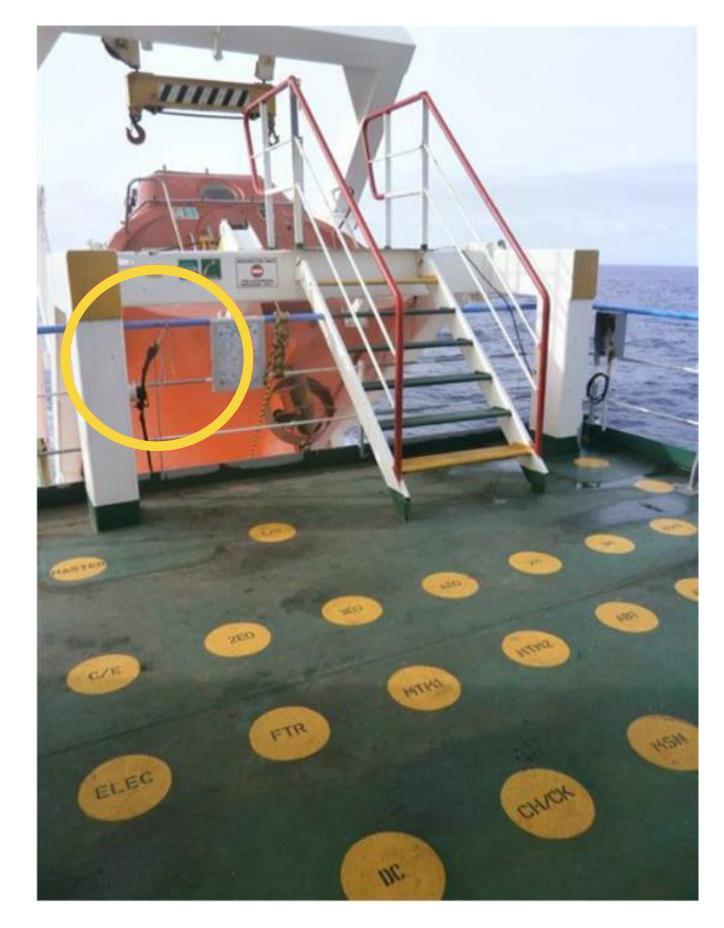
Working area for the original maintenance task (turnbuckle marked with a yellow circle).

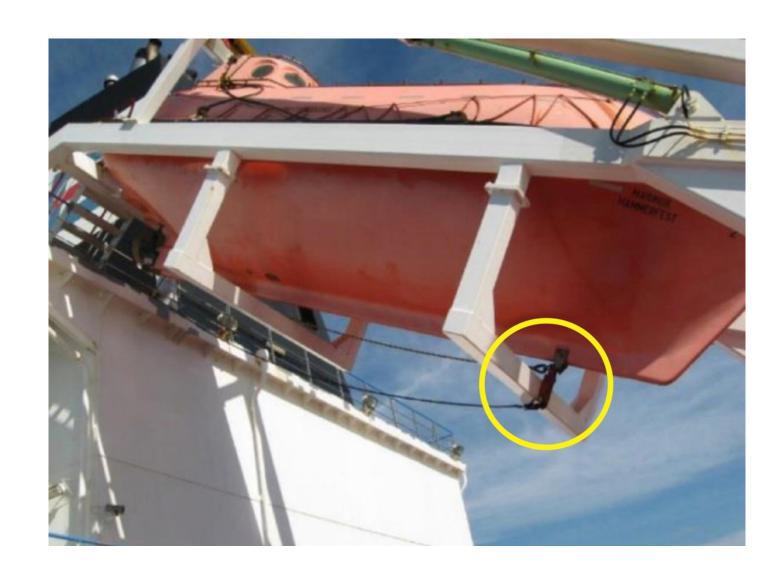
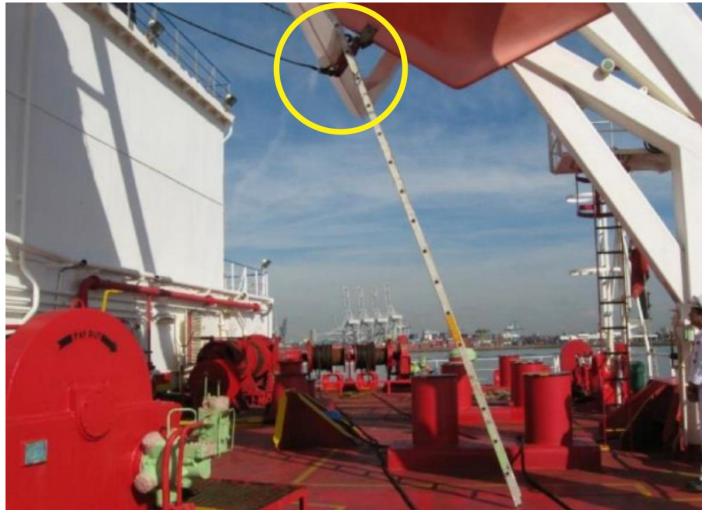
- While performing the task, the AB observed that the forward hook for the free-fall lifeboat needed lubrication
- AB asked the bosun to assist him by steadying a portable ladder to reach the forward hook
- The height from the deck to the hook was 4.8 metres
- The ladder was 5 metres long

Free-fall lifeboat and forward hook (marked with a yellow circle) with ladder as positioned by the AB

- Ladder was equipped with rubber feet at the bottom of each leg but not secured by any other means
- The AB climbed up without any form of protection (safety line, helmet, etc.)
- The bosun tried to prevent this, but held on to the ladder while the AB continued to climb up
- Ladder slipped, but the bosun was unable to prevent this
- The AB fell along with the ladder and ended up motionless on deck; he was tragically pronounced dead 3 hours later

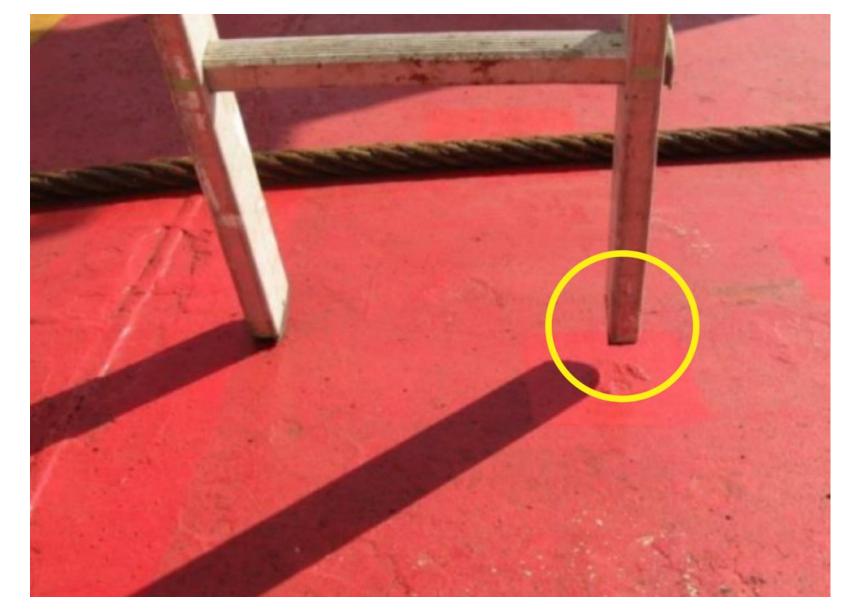
The feet of the ladder in the accident location

- **Use of unsafe equipment** The portable ladder was inappropriate for the task; the poor condition of the feet meant they were not both in contact with the deck. The fact that it had not been safely secured would also have contributed to it being unstable and probably contributed to the ladder slipping and the AB falling off it.
