Lone Watchkeeping – Grounding at Night

Lone Watchkeeping – Grounding at Night**BACKGROUND**

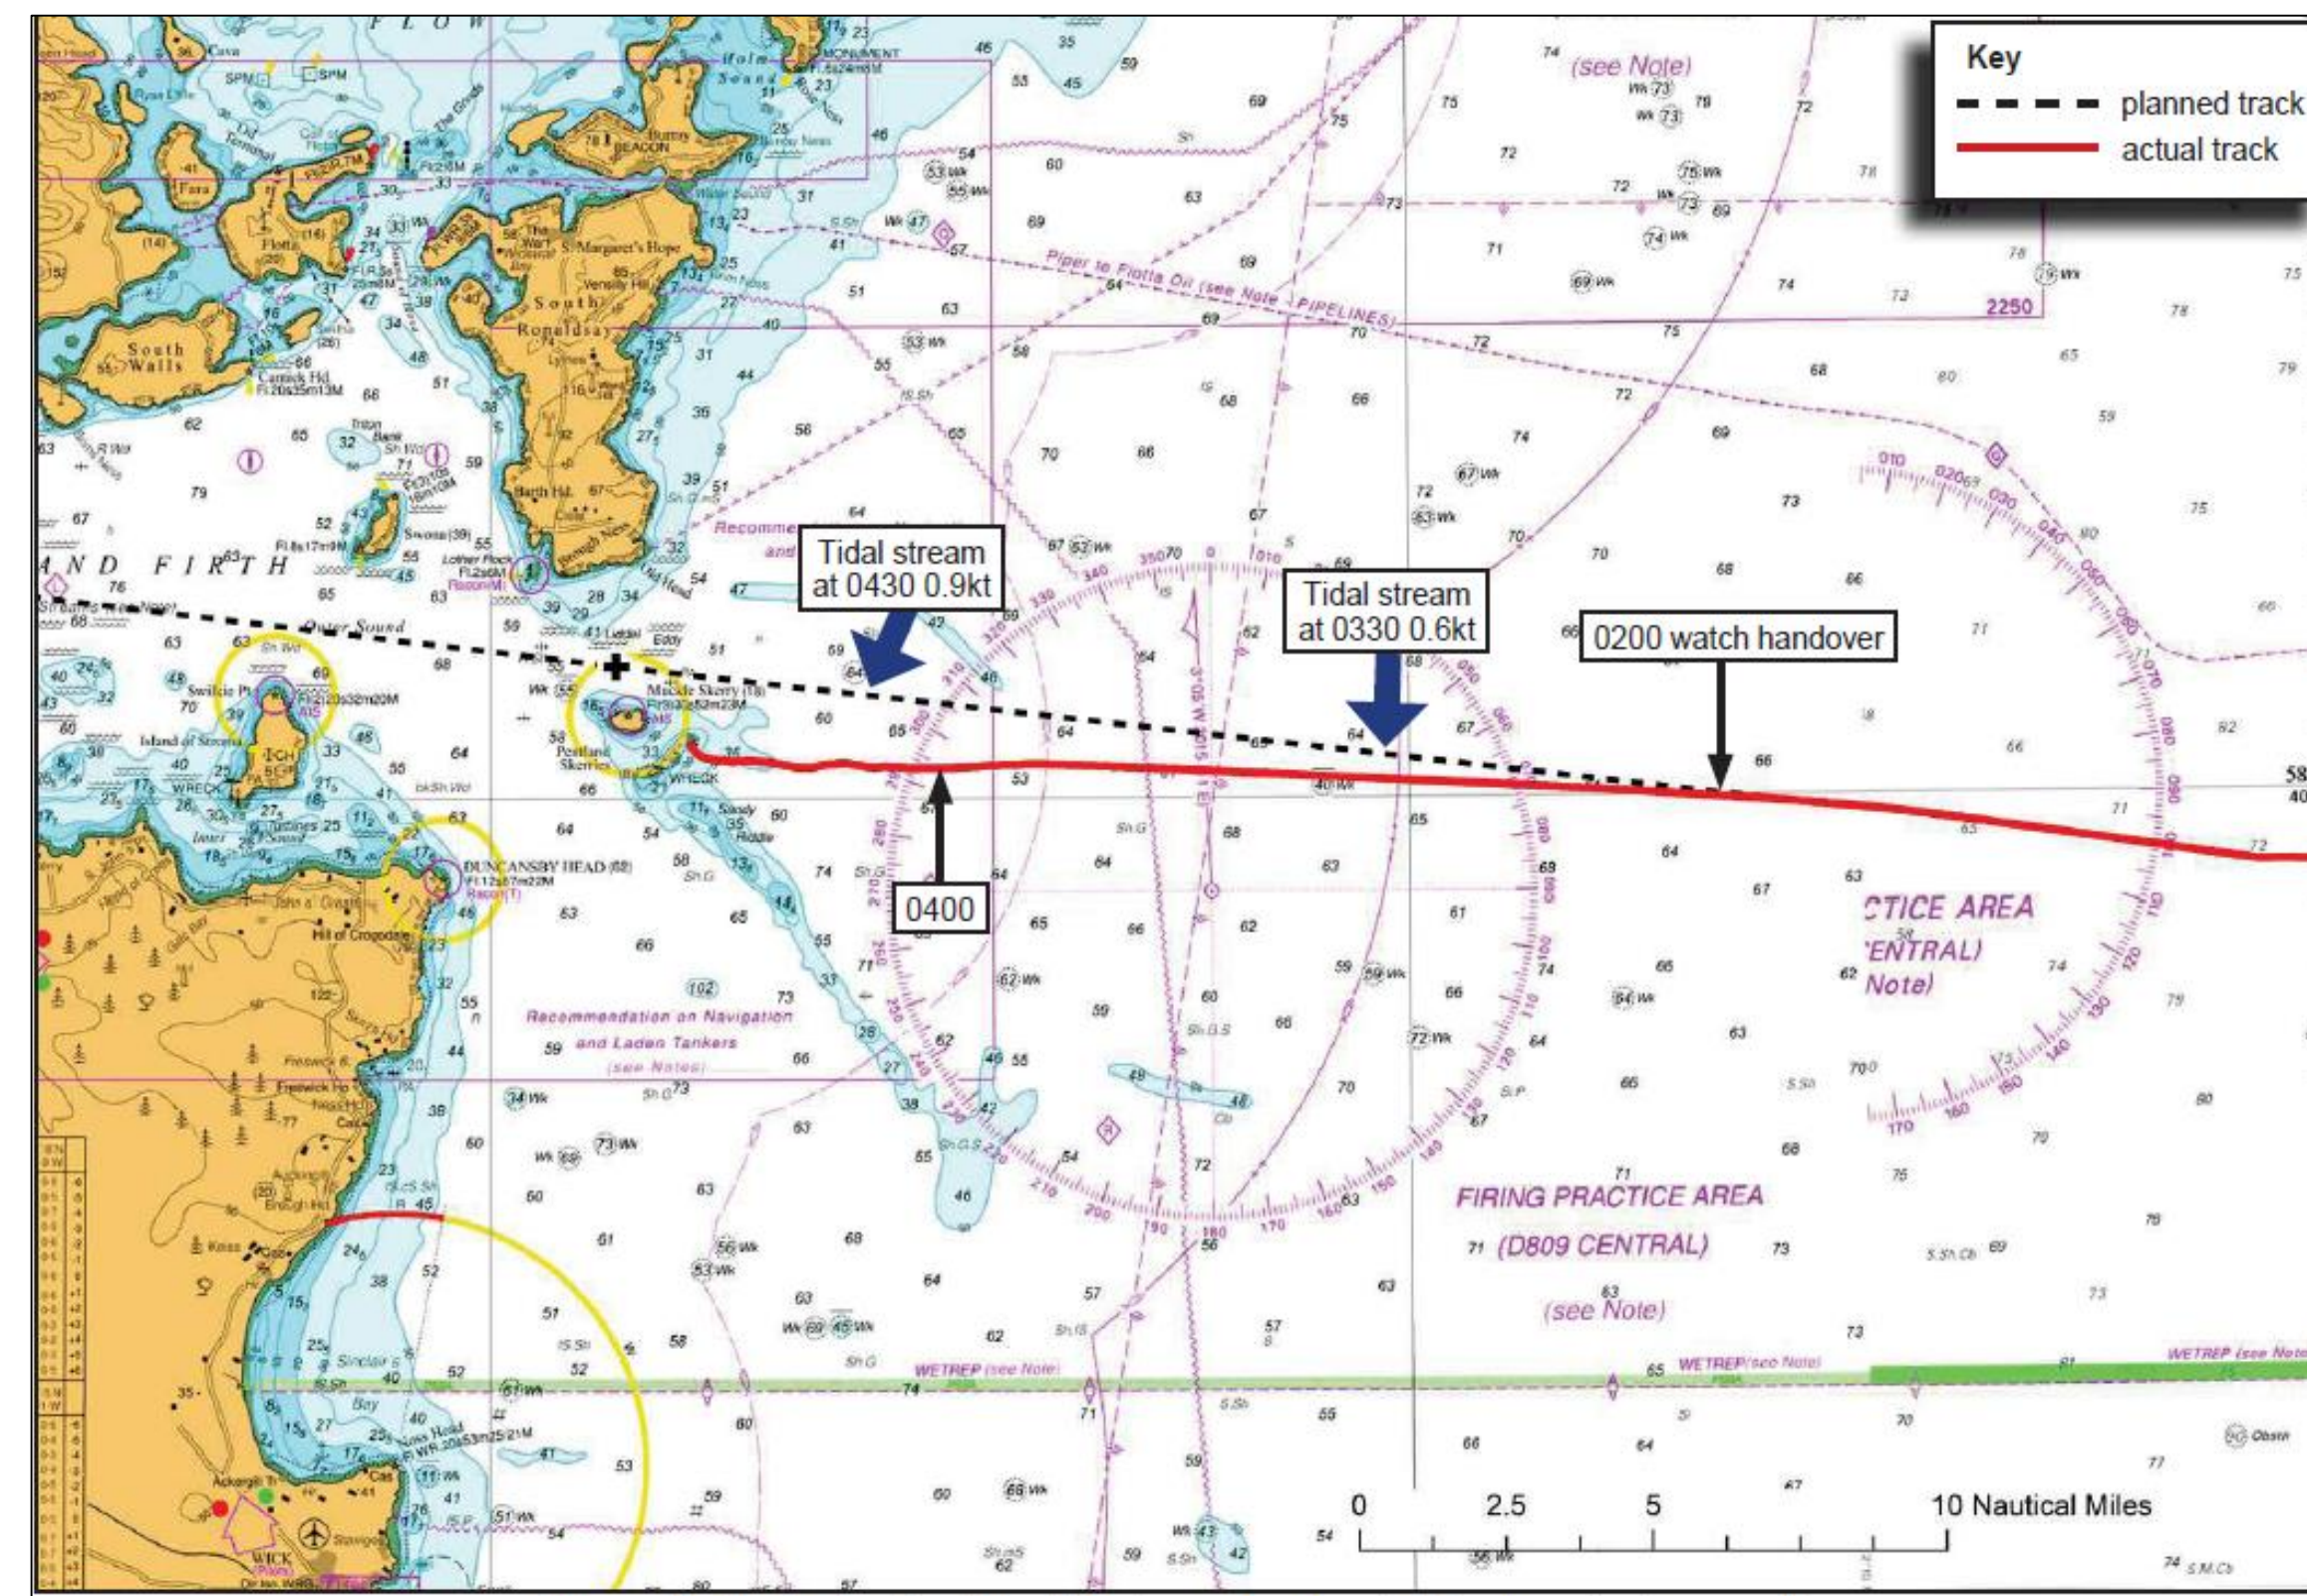
- At about 0400, the OOW realised that the ship was south of its planned track.
- Noticing two small islands on his radar, the OOW decided to proceed between the islands (Pentland Skerries) and thereafter alter course to starboard to regain the planned track.

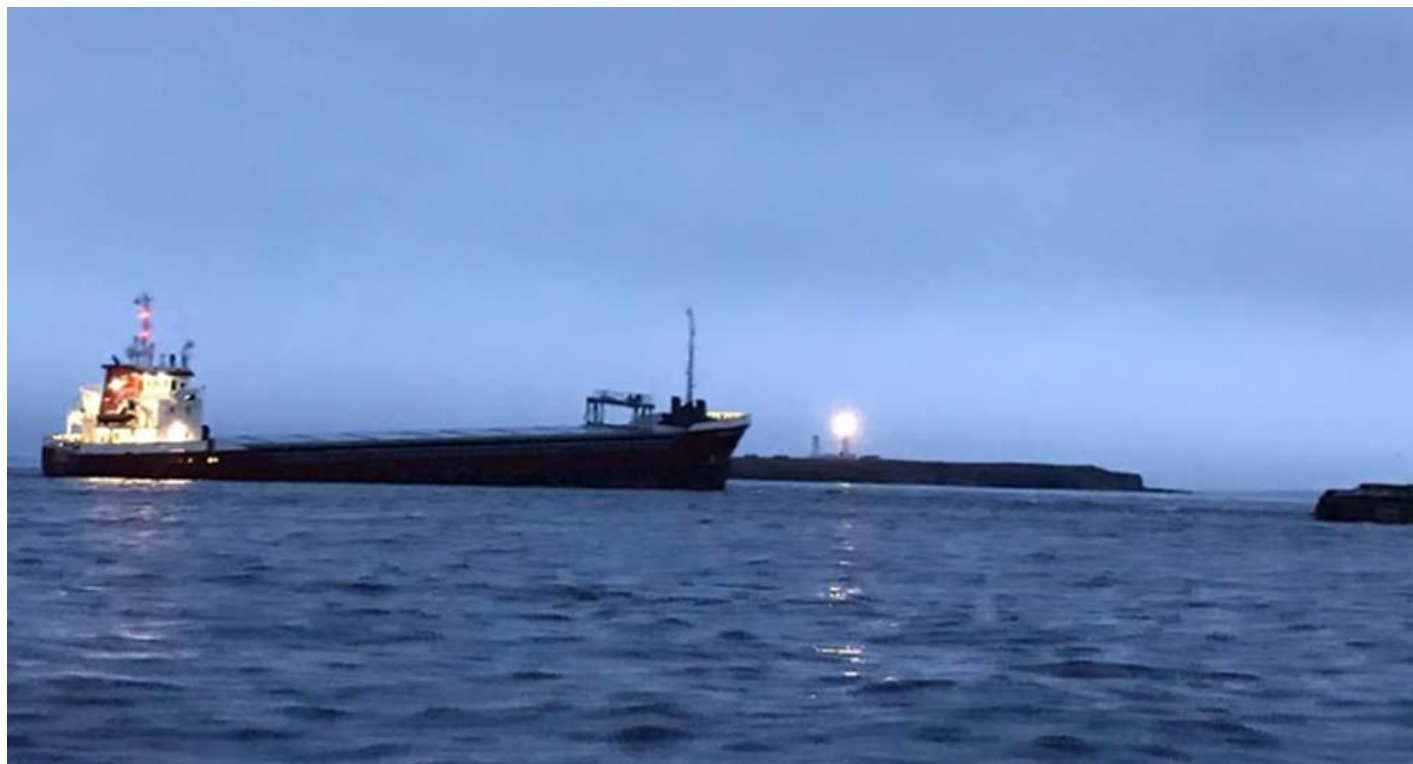
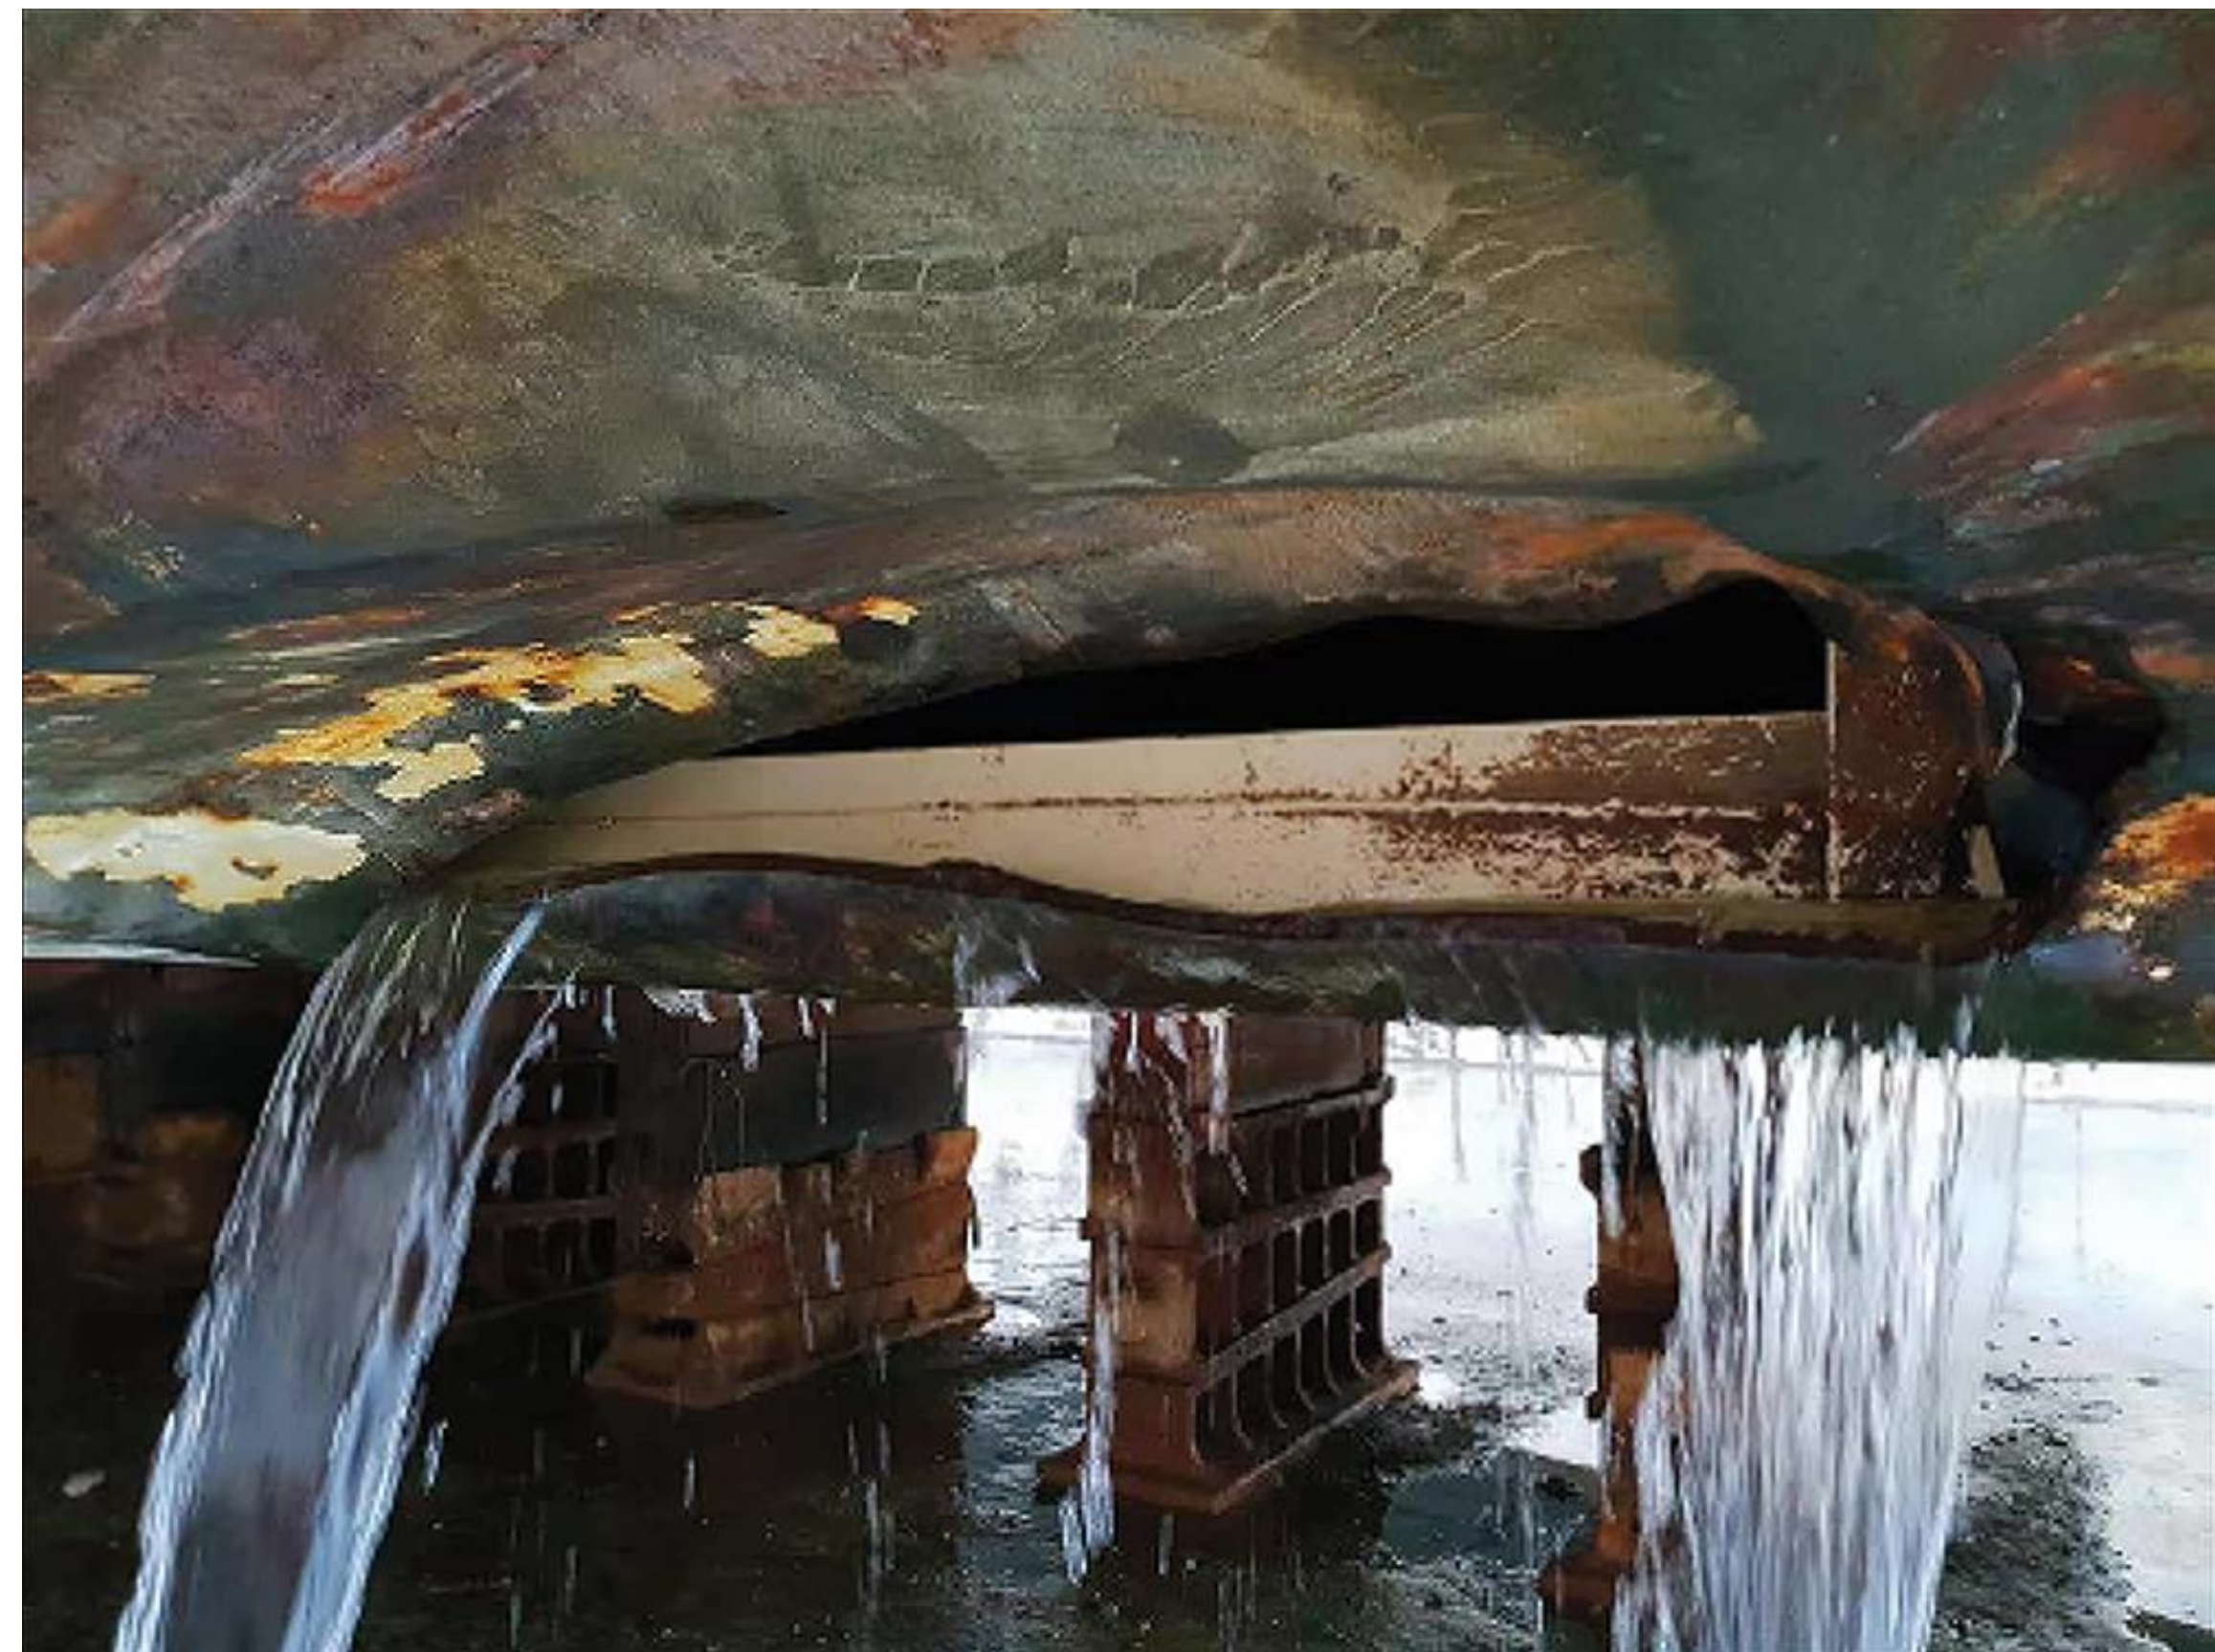
- At about 0443 the ship grounded on Pentland Skerries at a speed of 7 knots.

- The ship sustained extensive damage to its hull.
- Unable to be refloated until seven days after the incident.
