FATAL CRUSH INCIDENT

THIS CASE STUDY IS DRAWN FROM THE INVESTIGATION REPORT 18/2020 PUBLISHED BY THE MARINE ACCIDENT INVESTIGATION BRANCH (MAIB) (© Crown copyright, 2020) AT: <https://www.gov.uk/maib-reports/crush-incident-on-general-cargo-vessel-karina-c-with-loss-of-1-life>

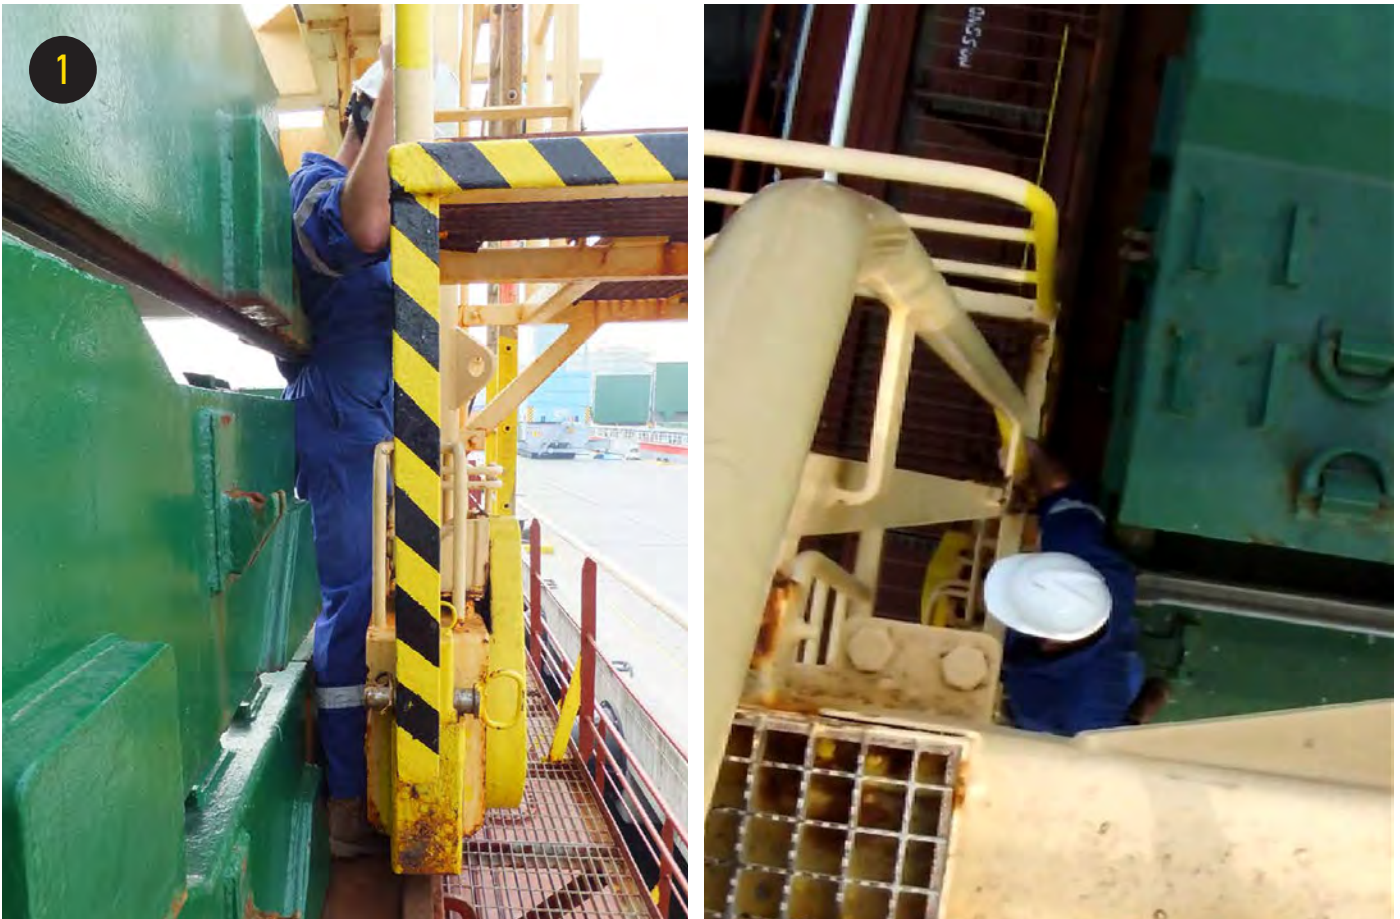
FIGURE 1 RECONSTRUCTION SHOWING A CREW MEMBER IN THE GAP BETWEEN THE LADDER PLATFORM AND STACKED HATCH COVERS.
SOURCE: MARINE ACCIDENT INVESTIGATION BRANCH (MAIB), © CROWN COPYRIGHT, 2020

As he stepped towards the gap between the crane and the stacked hatch covers (**Figure 4**), the lifting bar cleared the hatch cover stack and the C/O drove the crane aft. The 2/O screamed as he was trapped and crushed between the hatch covers and the crane's ladder access platform (**Figure 1**).

- The 2/O was crushed while he was trying to walk between the gantry crane and a stack of hold hatch covers when the C/O began to move the gantry crane aft at the same time. This reduced the gap between the crane's ladder platform and covers to around 130mm, trapping the 2/O.

- The 2/O was unaware that the C/O was about to move the crane, while the C/O was unaware that the 2/O was under the crane and about to climb through the gap. The 2/O's and C/O's situational awareness would have been enhanced if effective communications had been established and the deck operations had been properly controlled.

- Once the 2/O was within a couple of metres of the crane, he would not have been visible to the C/O at the gantry control position. Before moving the crane, the C/O should have moved from the crane's control position to check the walkways and ensure the area directly below was clear.

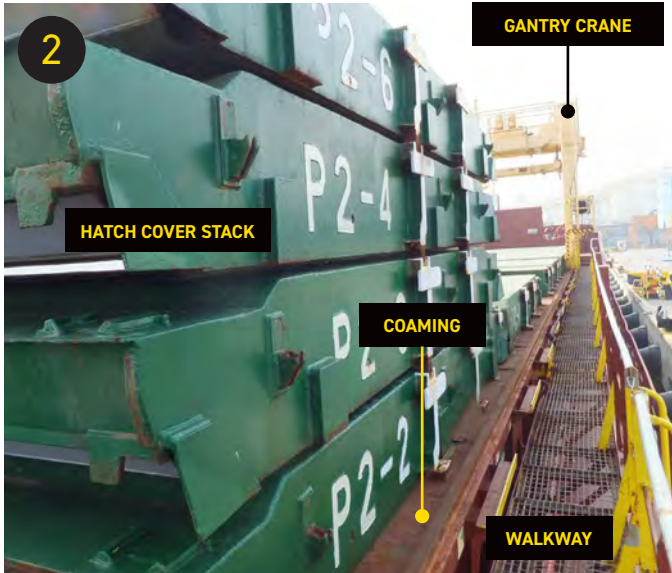
FIGURE 2 STARBOARD WALKWAY LOOKING FORWARD SHOWING STACK OF HATCH COVERS AND GANTRY CRANE.
SOURCE: MARINE ACCIDENT INVESTIGATION BRANCH (MAIB), © CROWN COPYRIGHT, 2020

After 0830, the C/O started to lift and close the pontoon-type hatch covers using the ship's rail-mounted gantry crane (**Figure 2**) and instructed the deck crew to commence cleaning cement dust from the hatch coamings. These tasks had to be completed before departure.

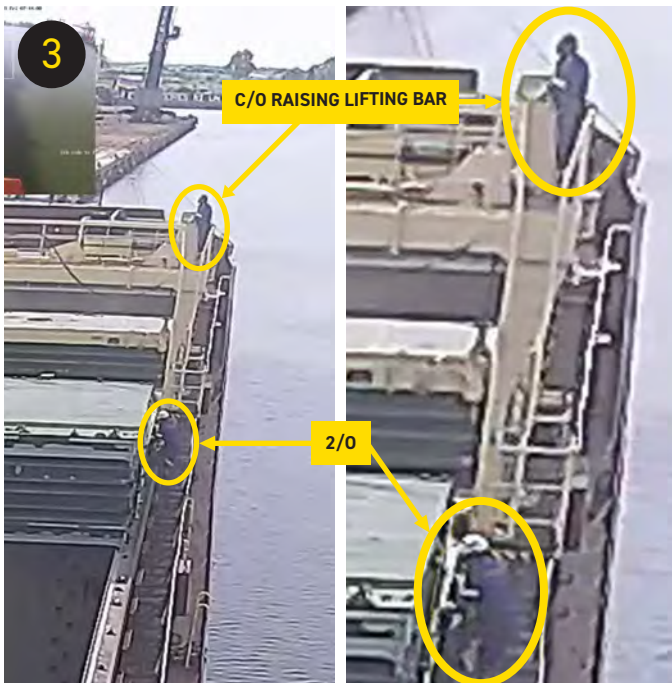
At 0942, the C/O moved a hatch cover to the forward end of the forward hold and lowered it into position and at 0943, he started to drive the gantry crane aft. At the same time, the 2/O finished sweeping and started to walk forward along the walkway, stopping briefly to speak to the AB working on the aft hold hatch cover. At 0944, the C/O stopped the crane just short of a stack of hatch covers at the forward end of the aft hold and started to raise the crane's lifting bar. At 0944:10, the 2/O arrived at the forward end of the hatch cover stack and climbed onto the hatch coaming (**Figure 3**).

FIGURE 3 ZOOMED CLOSED-CIRCUIT TELEVISION (CCTV) SCREENSHOT LOOKING FORWARD SHOWING THE 2/O CLIMBING ONTO THE CARGO HOLD HATCH COAMING AT 0944:10.
SOURCE: MARINE ACCIDENT INVESTIGATION BRANCH (MAIB), © CROWN COPYRIGHT, 2020

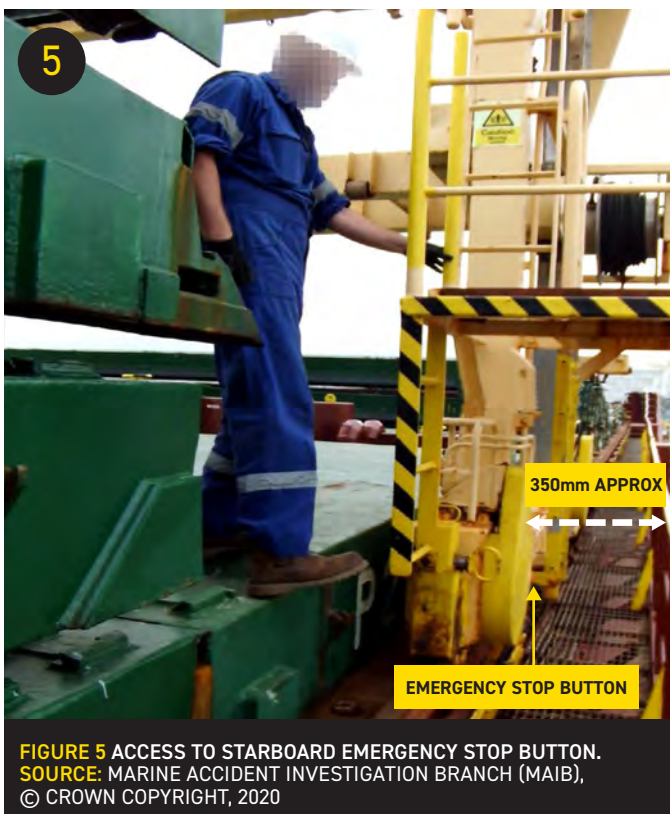
The investigation noted that an emergency stop button was fitted to the crane platform, but the 2/O would have been unable to reach this while in the gap between the platform and covers (**Figure 5**).

- The crane's deck level emergency stop buttons could only be operated from the walkways and could not be reached by the 2/O before and after he became trapped.

- The gantry crane was fitted with a loud warning bell and flashing amber light, but these only operated while it was moving. The 2/O would have been alerted to the crane's imminent movement if it had been fitted with a pre-movement warning device.
