## FALL OF A HEAVY OBJECT, RESULTING IN INJURY

TWO CREW MEMBERS ON A GENERAL CARGO SHIP WERE INJURED WHEN A SUSPENDED LOAD FELL AND STRUCK THEM. THE SUSPENDED LOAD WAS WIRE ROPE LEGS AND SHACKLES USED TO MOVE THE SHIP'S HATCH COVERS ('THE LIFTING GEAR'), WHICH FELL BECAUSE THE HOIST PARTED AFTER ONE OF THE SHACKLES BECAME SNAGGED I.E. WEDGED ON A COAMING AT THE STORAGE LOCATION.

# INCIDENT CASE STUDY

No.9 | JULY 2021

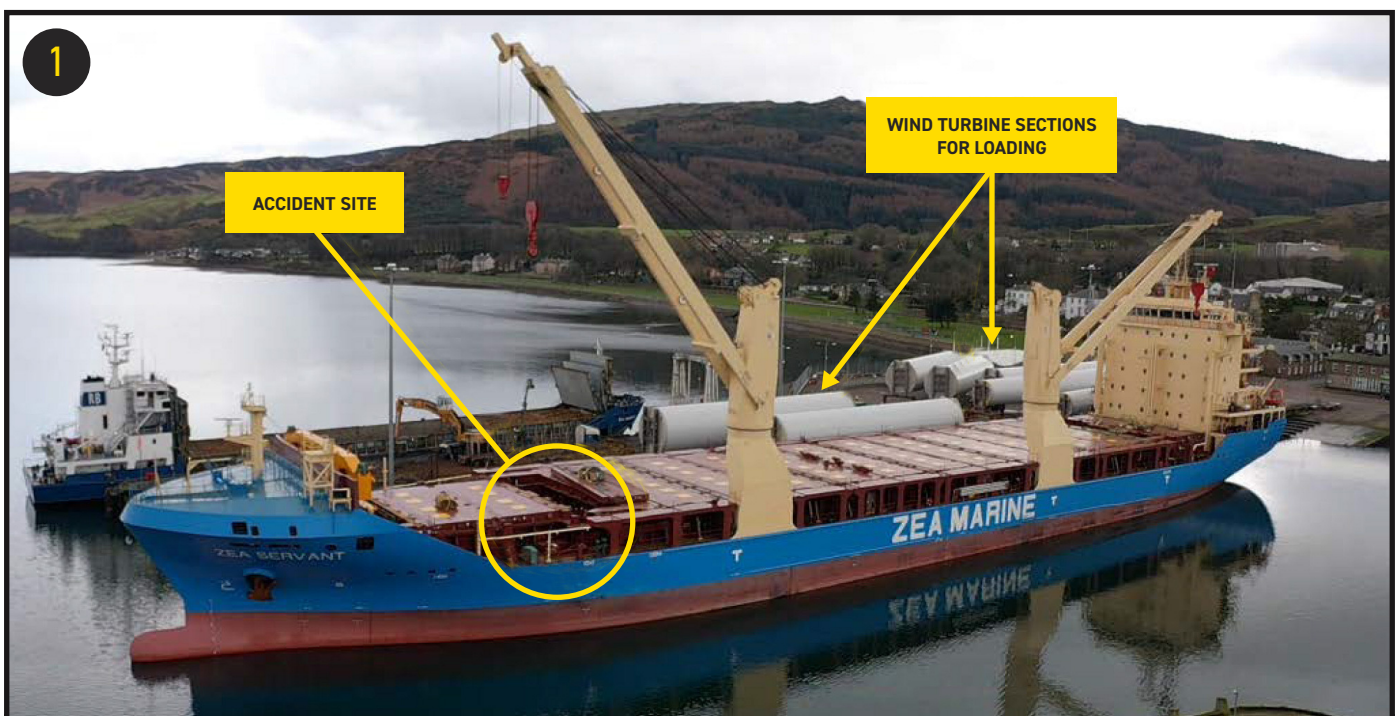
**FIGURE 1** THE SHIP IN BERTH, SHOWING ACCIDENT SITE AND WIND TURBINE SECTIONS FOR LOADING.  
**SOURCE:** MARINE ACCIDENT INVESTIGATION BRANCH (MAIB)

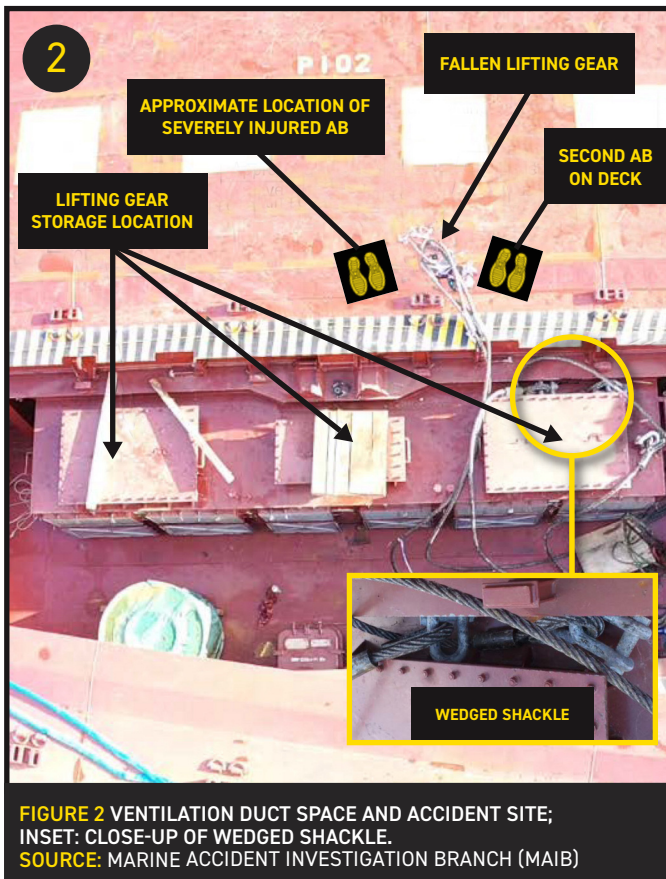
Following the safety briefing, one of the able-bodied seamen (A/B) used the ship's forward crane to remove the cargo hold ventilation duct space cover (**Figure 2**), so that the lifting gear could be retrieved. Two other A/Bs then entered the ventilation duct space and attached the first of two hatch cover lifting gear sets to the crane's hook using a fibre sling (**Figure 3**). Both A/Bs then climbed out of the space and stood close to the hatch edge ready to guide the load and free any snags as it was lifted.

Shortly after the lifting operation recommenced, a shackle at the lower end of the load became snagged on a ventilation trunk coaming (**Figure 2 inset**). The C/O immediately instructed the crane driver to stop, but at the same time the fibre sling parted and the lifting gear fell to the deck, striking both A/Bs.

- The ship had not been built with a dedicated storage area for the hatch cover lifting gear. As a result, the crew had devised a local arrangement to store the lifting gear on top of wooden pallets in the duct space which might have appeared appropriate because it was accessible. However, it was an area where there was a significant number of potential snagging hazards, especially for lifting slings with shackles at their ends. It is likely that a formal risk assessment process would have identified the cargo hold ventilation duct space as an unsuitable location for the stowage of the lifting gear, and prompted the crew and/or vessel operator to consider alternative options. It is evident that the storage arrangement was not appropriate, and that a more suitable alternative was required.

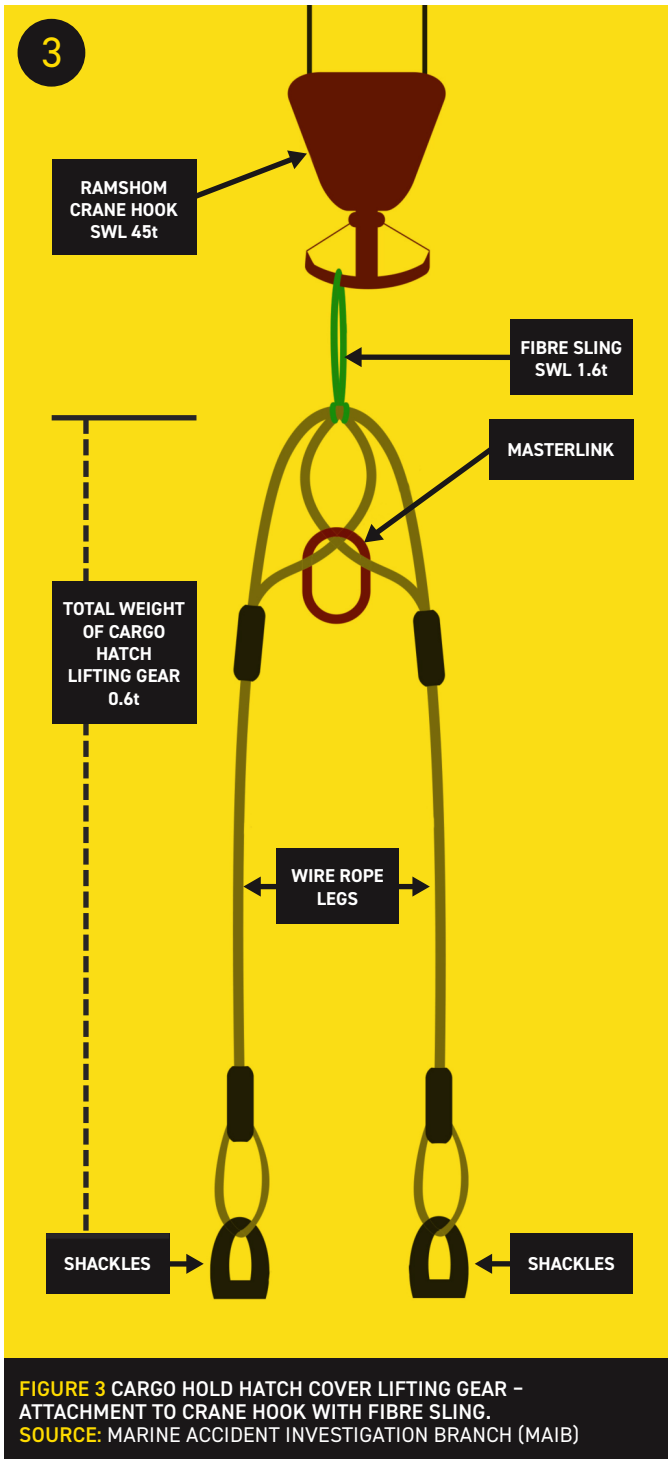
The hatch cover lifting gear had been stowed on wooden pallets positioned on top of the ventilation duct coamings in the ventilation duct space ever since delivery by the shipbuilder. There was no designated storage space for the lifting gear on board. The lifting gear was made up of two slinging sets; each set weighed 0.6t and consisted of two 17m long, 52-millimetre (mm) diameter, wire rope legs joined together with a master link (**Figure 3**). Each wire leg had a shackle attached to an eye at the lower end.

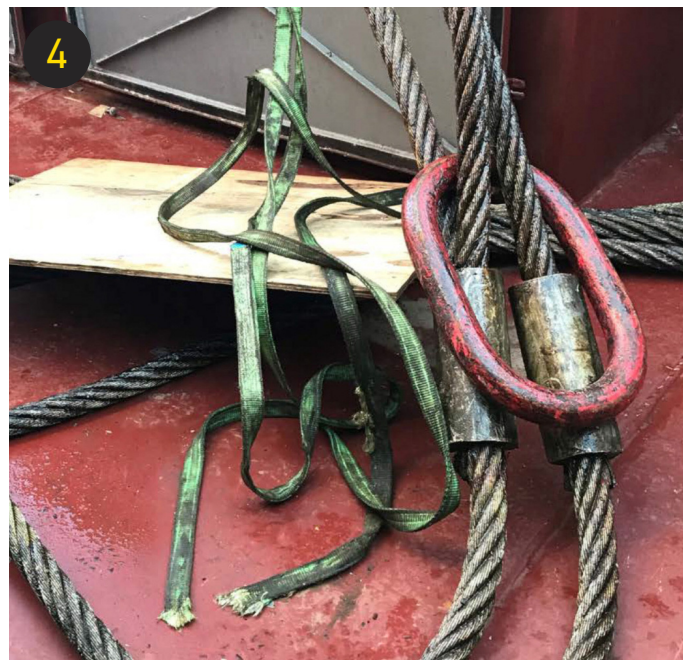
After the accident the parted sling (**Figure 4**) and five other similar slings from the ship were examined at an expert testing centre. The report of these tests stated that all six slings would have failed a visual inspection as they were soiled and had illegible identification markings.

**FIGURE 4 BROKEN FIBRE SLING (AFTER THE ACCIDENT).**  
**SOURCE:** MARINE ACCIDENT INVESTIGATION BRANCH (MAIB)

- The load fell because the synthetic fibre sling used to lift it parted under tension. It was reasonable to use such a fibre sling as its SWL was more than twice the weight of the load being lifted when rigged using a choke hitch. However, the fibre sling in use was in a poor condition, with local damage, soiling and illegible identification markings. It therefore should have been discarded.
