Serious Injury While Securing Containers

## Serious Injury While Securing Containers

- The **BOSTON TRADER**, a 9,528GT multipurpose dry cargo ship built in 2004, was moored in the port of Oran, Algeria since 11 March 2019 and cargo operations were in progress.
- During the morning of 14 March 2019 the third officer (3/O), bosun (BSN) and two able bodied seamen (A/Bs) had been on watch since 0600. The bosun was keeping a watch on the ship's gangway, while one AB (AB1) was securing the containers loaded on deck and another (AB2) was on the pier checking and sealing containers about to be loaded.
- While the containers were being loaded, AB1 was positioned in the cross-deck between Bay 06 and Bay 12.
- On the day of the incident the injured AB1 had six hours of rest before resuming his duty at 0600, which met the relevant requirements. The investigation did not consider drugs or alcohol to have contributed to this incident.

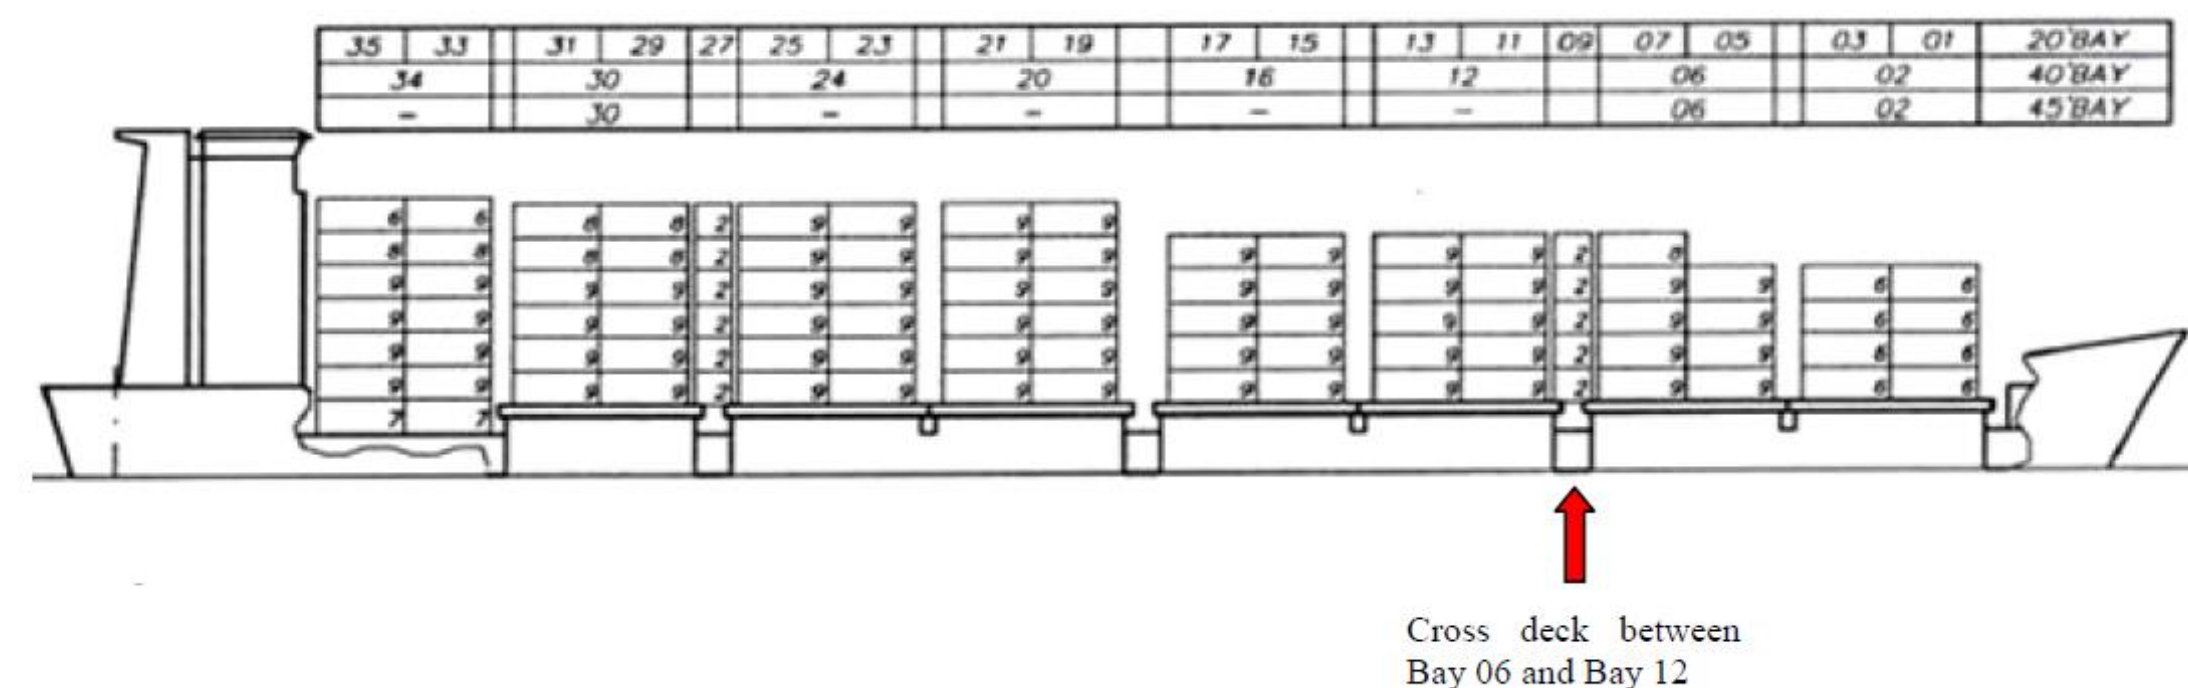
*Location of the incident:*  
*cross deck between Bay 06 and Bay 12*  
 Source: Investigation Report 04/2020 by Transport Malta

- A 40ft container was loaded in Bay 06 on the third tier, towards the outboard end of the starboard side of the ship. In order to secure it, AB1 stepped onto the hatch cover of cargo hold No. 2 and hooked up a long lashing bar into the corner fitting of the container. While holding the hooked-up lashing bar with one hand, he then stepped down from the hatch cover onto the cross deck in order to lift the turnbuckle with the other hand.
- At this point the lashing bar slipped out from the container socket and fell vertically down onto his right foot. The bottom end of the lashing bar cut through the safety footwear and injured his foot.

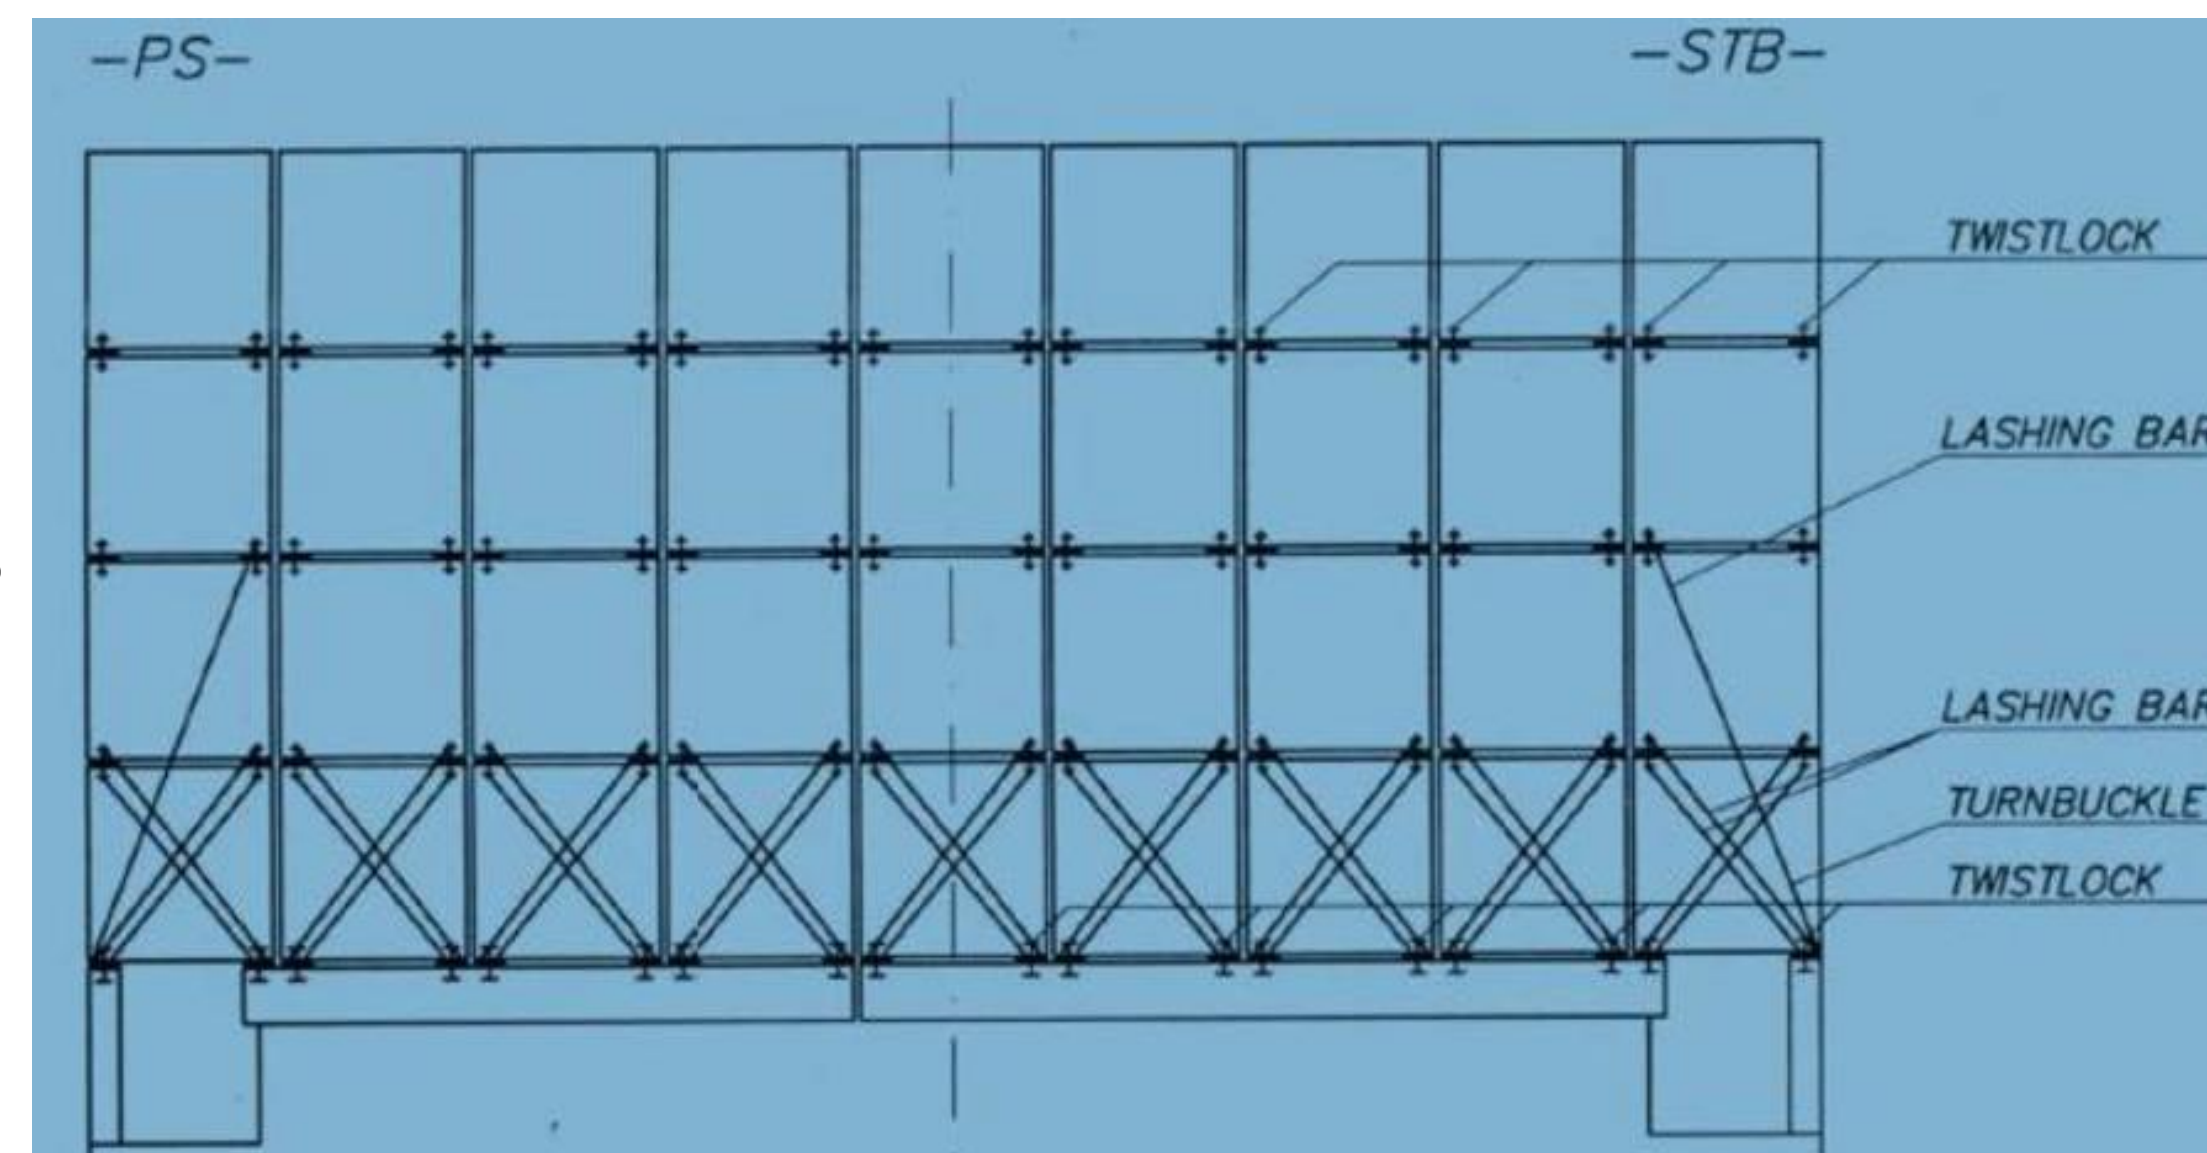
- The containers loaded on the third tier of the outboard ends had to be secured using a long lashing bar and tightened with a turnbuckle connected to it. The height of the long lashing bar was 5.07m and it was said to weigh more than 20kg.
- The person securing the containers would usually have to step onto the hatch cover, using it as a pedestal, to hook the lashing bar into the corner fitting of a container.
- Once hooked, the lashing bar would have to be brought diagonally across to be connected to the turnbuckle, which would then be screwed down to tighten the securing arrangement.

Container stowage and lashing plan – Bay 06  
Source: Investigation Report 04/2020 by Transport Malta

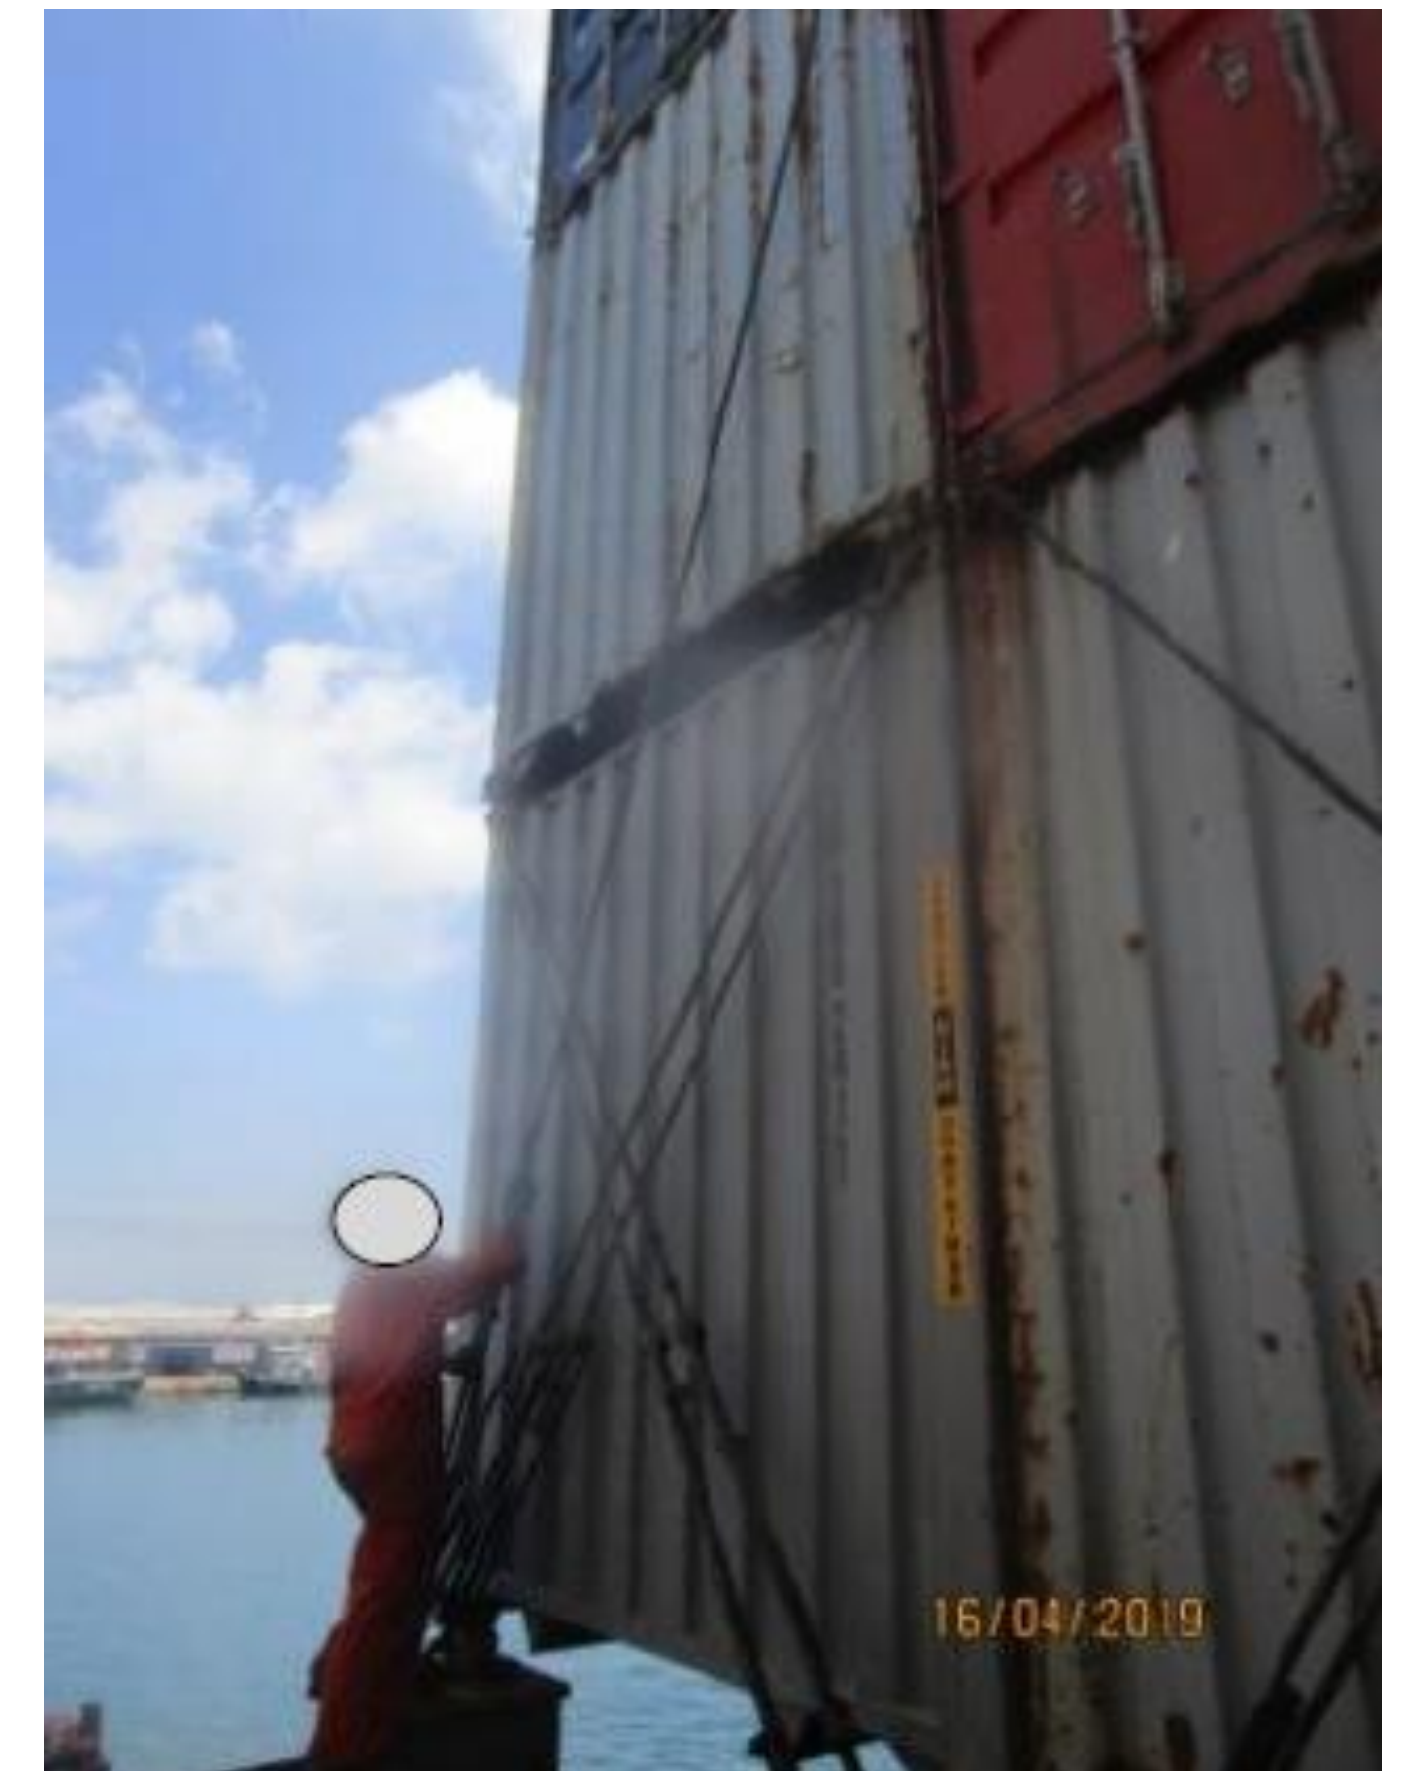
*Connecting a lashing bar to a turnbuckle*  
Source: Investigation Report 04/2020 by Transport Malta

- **Sufficient personnel for the securing of containers:** Taking into account the design of the long lashing bar and the securing arrangements, the investigation found that at least two persons were required to secure the containers: one to hold the hooked up long lashing bar and the other to connect it to the turnbuckle lying flat on the hatch cover.

- **Slipping of the lashing bar from the corner fitting:** A lashing bar would only lock into the socket of corner fitting, once rotated diagonally and connected to the turnbuckle. In view of the design, a lashing bar suspended vertically might slip out from the socket of the corner fitting, especially if not hooked correctly.

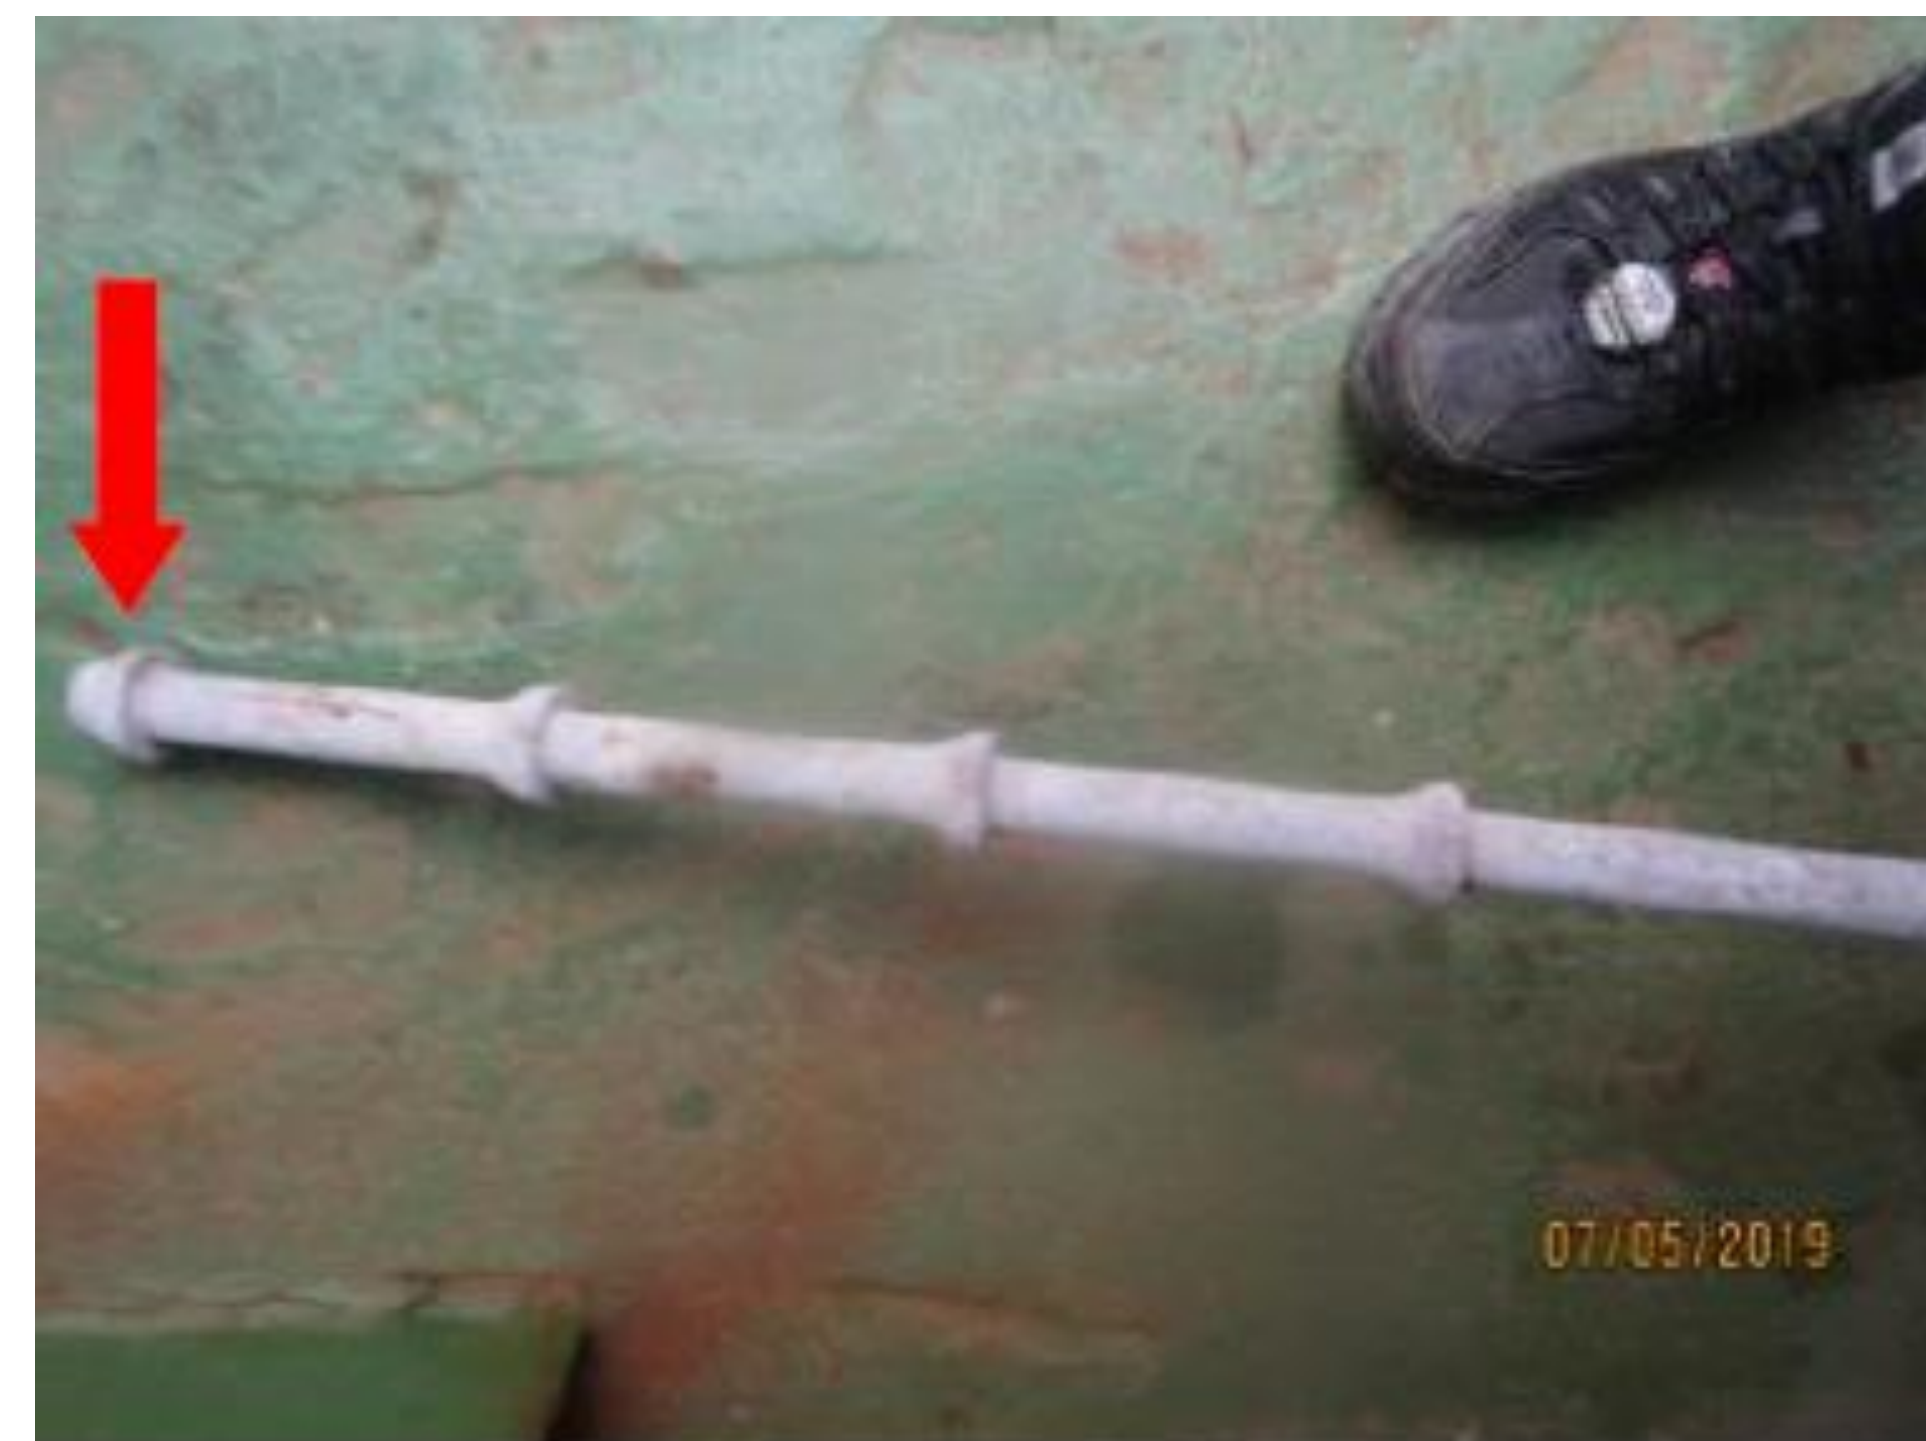
*The bottom end of the lashing bar*

- **Correct application of PPE:** The injured seafarer may have either worn his safety footwear improperly, or his foot slipped out at the time of the incident. The part of the shoe which was struck by the lashing bar did not match with the position where the injury was sustained, which occurred in the part of the foot usually well protected by the steel toecap.

**PPE** provided as appropriate for the activity and risk  
**MONITORING THE USE** of PPE to ensure it is fit for purpose and used correctly
