SERIOUS INJURY WHILE SECURING CONTAINERS

THE *BOSTON TRADER*, A 9,528GT MULTIPURPOSE DRY CARGO SHIP BUILT IN 2004 (FIGURE 1), WAS MOORED IN THE PORT OF ORAN, ALGERIA. WHILE THE CREW WERE SECURING THE CONTAINERS LOADED ON DECK, A SEAFARER WAS HIT ON THE FOOT BY THE LOWER END OF A FALLING LASHING BAR, WHICH RESULTED IN A SERIOUS INJURY AND A TOE BEING AMPUTATED.

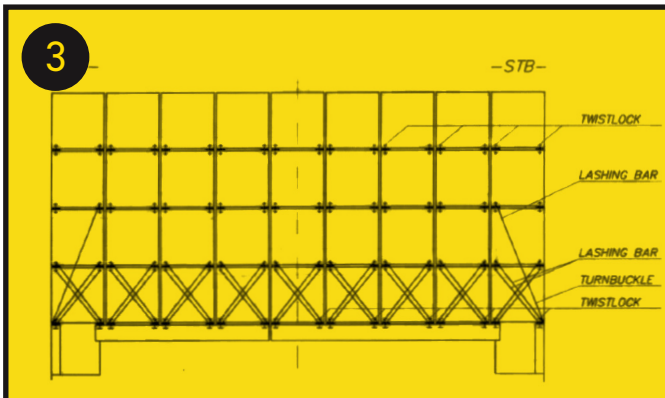
FIGURE 3 CONTAINER STOWAGE AND LASHING PLAN – BAY 06
SOURCE: INVESTIGATION REPORT 04/2020 BY TRANSPORT MALTA

The containers loaded on deck were secured in accordance with the Cargo Securing Manual, which required the containers stowed on the hatch cover of No. 2 cargo hold (Bay 06), in the vicinity of where the accident occurred (**FIGURE 2**), to be secured as shown in **FIGURE 3**.

While the containers were being loaded, AB1 was positioned on the cross-deck between Bay 06 and Bay 12. The containers loaded on the third tier of the outboard ends had to be secured using a long lashing bar and tightened with a turnbuckle connected to it. The height of the long lashing bar was 5.07m and it was estimated to weigh more than 20kg.

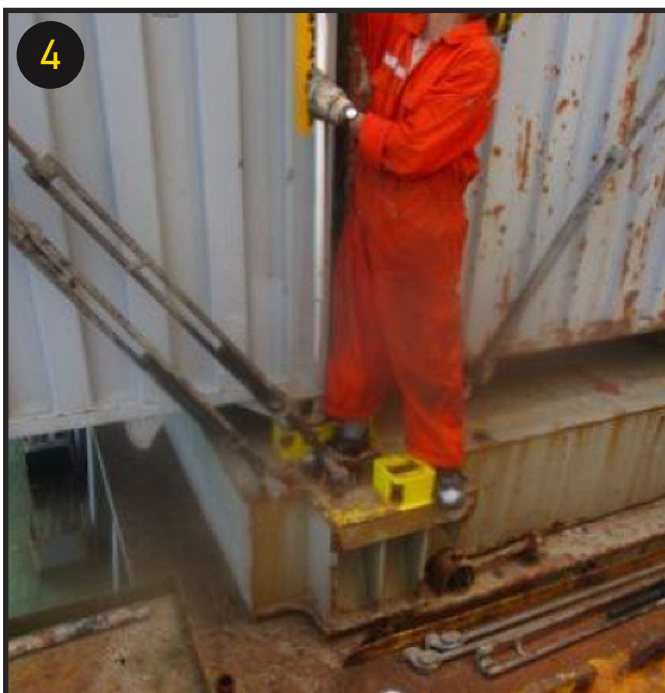
FIGURE 4 HOOKING A LASHING BAR INTO A CORNER FITTING
SOURCE: INVESTIGATION REPORT 04/2020 BY TRANSPORT MALTA

The person securing the containers would usually have to step onto the hatch cover, using it as a pedestal, to hook the lashing bar into the corner fitting of the container (**FIGURE 4**). Once hooked, the lashing bar would have to be brought diagonally across to be connected to the turnbuckle, which would then be screwed down to tighten the securing arrangement (**FIGURE 5**).

A 40ft container was loaded in Bay 06 on the third tier, towards the outboard end of the starboard side of the ship. In order to secure it, AB1 stepped onto the hatch cover of cargo hold No. 2 and hooked up a long lashing bar into the corner fitting of the container. While holding the hooked-up lashing bar with one hand, he then stepped down from the hatch cover onto the cross deck in order to lift the turnbuckle with the other hand.

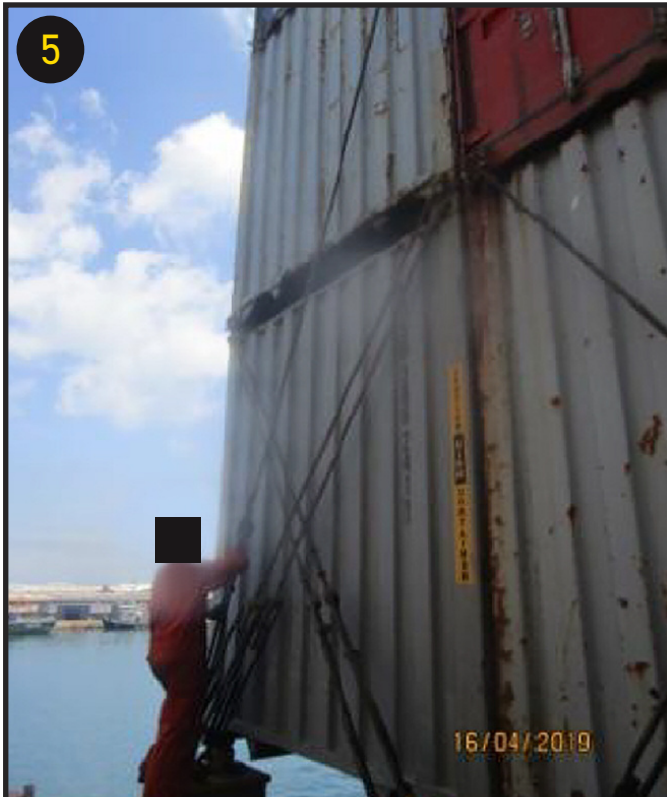
FIGURE 5 CONNECTING A LASHING BAR TO A TURNBUCKLE
SOURCE: INVESTIGATION REPORT 04/2020 BY TRANSPORT MALTA

- **SUFFICIENT PERSONNEL FOR THE SECURING OF CONTAINERS** Although the crew members believed that the securing of loaded containers could be carried out by only one person, taking into account the design of the lashing bar and the securing arrangements, the investigation found that at least two persons were required to secure the containers: one to hold the hooked up lashing bar and the other to connect it to the turnbuckle lying flat on the hatch cover. With just one person, securing the containers on the third tier would have increased the risk of injury when the lashing bar was being lifted.

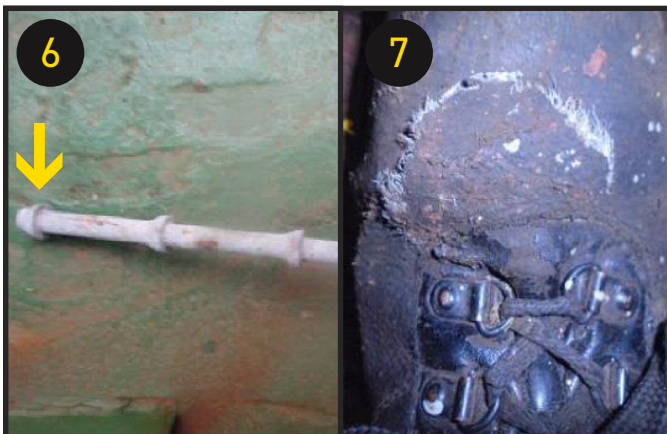
FIGURE 6 THE BOTTOM END OF THE LASHING BAR
FIGURE 7 THE SAFETY SHOE OF THE INJURED SEAFARER
SOURCE: INVESTIGATION REPORT 04/2020 BY TRANSPORT MALTA

At this point the lashing bar slipped out from the container socket and fell vertically down onto his right foot. The bottom end of the lashing bar (**FIGURE 6**) cut through the safety footwear (**FIGURE 7**) and injured his foot.

- **CORRECT APPLICATION OF PPE** The injured seafarer may have either worn his safety footwear improperly, or his foot may have slipped out at the time of the incident. Although he was wearing the right PPE and the correct size, the effectiveness of the safety shoes could have been compromised. The part of the shoe which was struck by the lashing bar did not match with the position where the injury was sustained, which occurred in the part of the foot usually well protected by the steel toecap.

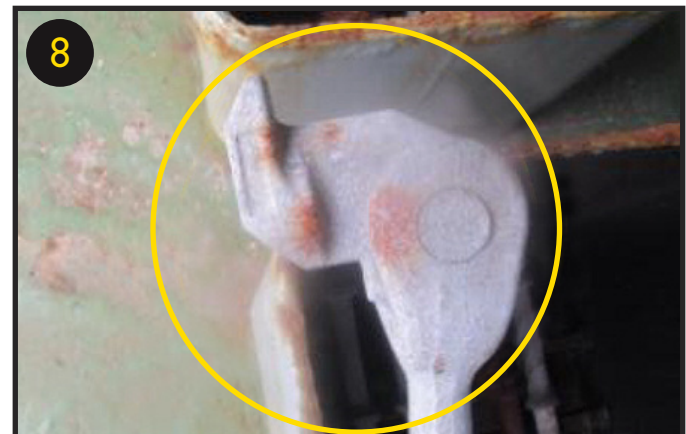
FIGURE 8 UPPER END (HOOK) OF THE LASHING BAR
SOURCE: INVESTIGATION REPORT 04/2020 BY TRANSPORT MALTA

- **SLIPPING OF THE LASHING BAR FROM THE CORNER FITTING** The upper end of the lashing bar is shown in FIGURE 8. The sockets of corner fittings into which lashing bars are hooked are oval in shape. A lashing bar, such as the one being used by the injured seafarer, was designed to slip easily into the socket of the container and to lock into the socket, once the bar is rotated diagonally across and connected to the turnbuckle. In view of this design, if the lashing bar is left suspended vertically, it may slip out from the socket of the corner fitting, especially if it is not hooked correctly.
