ACCIDENTAL RELEASE OF A LIFEBOAT

A REFRIGERATED CARGO SHIP HAD BERTHED IN SOUTHAMPTON TO DISCHARGE A CARGO OF FRUIT. ON THE DAY OF ARRIVAL THE LOCAL PORT STATE AUTHORITIES HAD BOARDED THE SHIP IN ORDER TO CONDUCT A PORT STATE CONTROL (PSC) INSPECTION, WHICH INCLUDED A LIFEBOAT DRILL. WHILE SECURING THE LIFEBOAT AFTER THE DRILL, THE SHIP'S BOSUN SUSTAINED MINOR INJURIES AS THE FORWARD END OF THE LIFEBOAT FELL FROM ITS DAVIT DUE TO IT NOT BEING CORRECTLY RESET WHEN IT WAS HOISTED FROM THE WATER (**FIGURE 1**).

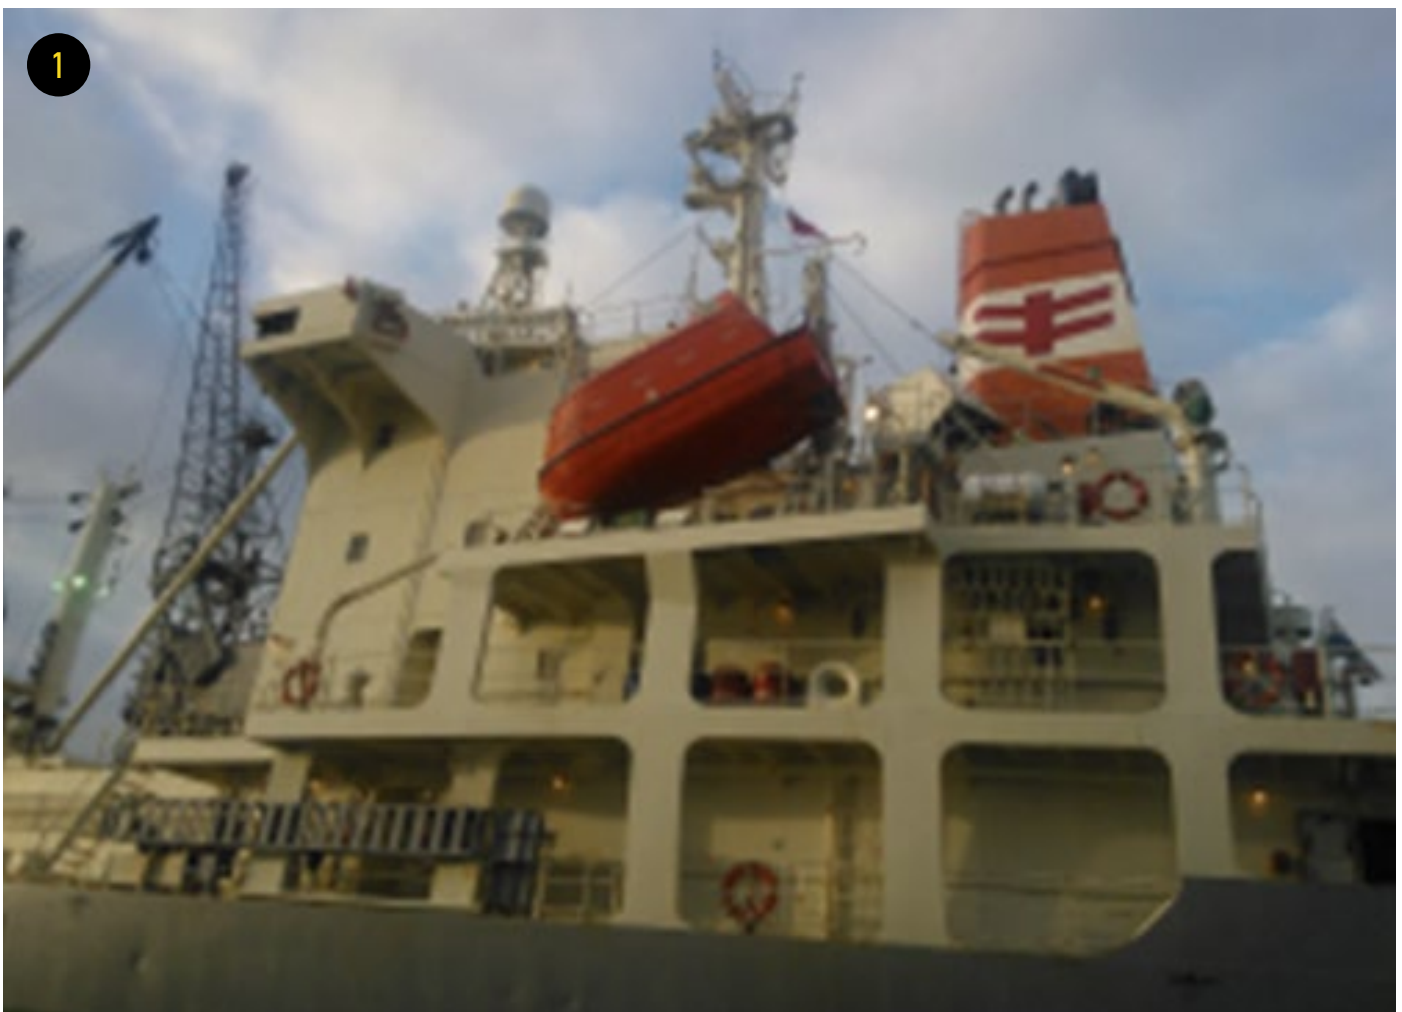
FIGURE 1 PORT SIDE LIFEBOAT AFTER THE INCIDENT
SOURCE MARITIME ACCIDENT INVESTIGATION BRANCH

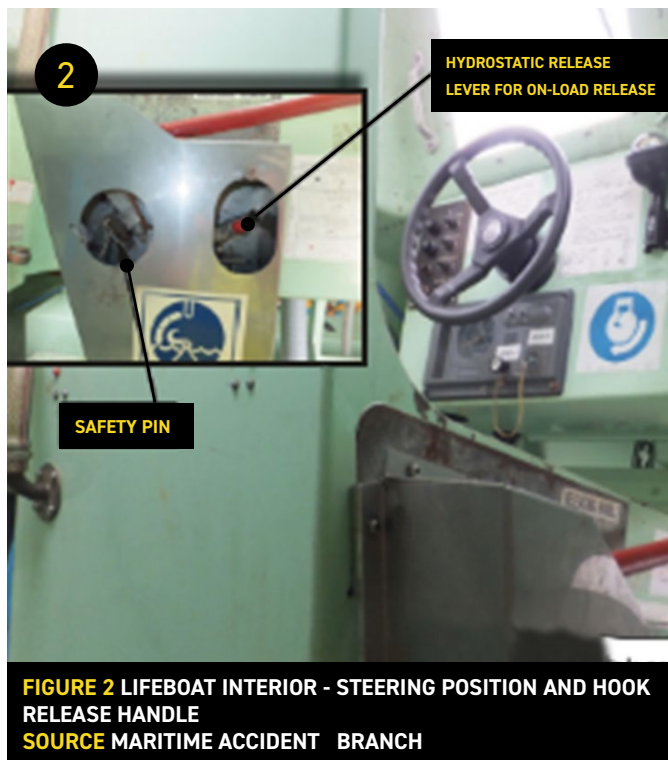
The C/O used a portable Very High Frequency (VHF) radio to instruct the crewman operating the lifeboat davit winch on the embarkation deck to release the brake and lower the lifeboat into the water. When the lifeboat was in the water its engine was started and the C/O pulled the hook release handle (**FIGURE 2**) to free the boat from the davit suspension links. However, the hooks failed to open. The C/O pulled the release handle again and this time the hooks opened and released the lifeboat from the davit suspension links. The C/O took the helm and manoeuvred the lifeboat clear of the ship and sailed around for about ten minutes before returning and bringing the lifeboat alongside the ship in order to be lifted. During the preparation to be hoisted the lifeboat crew experienced difficulties resetting the hook release gear and two crewmen were required to pull on the hook release handle to force it into a position in which the safety pin could be inserted.

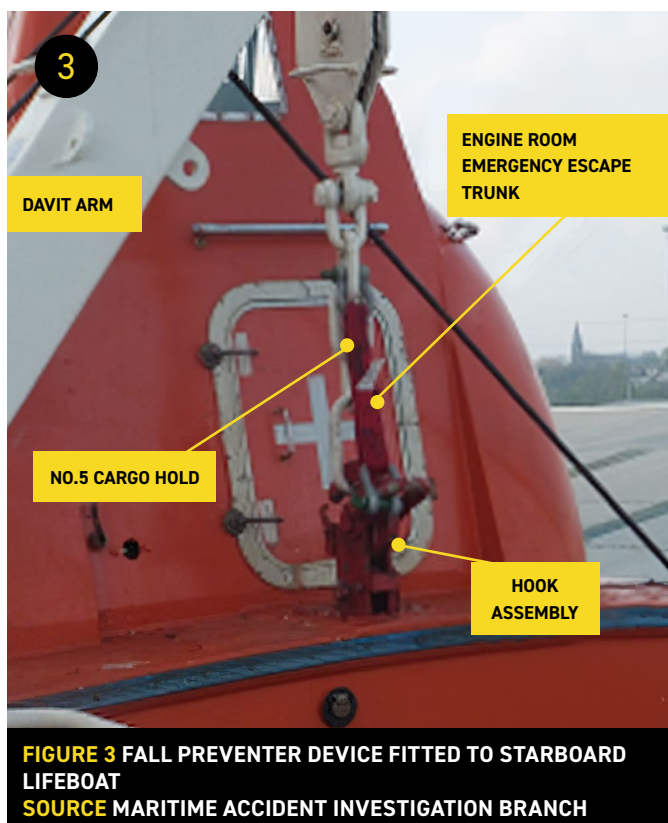
With the lifeboat in position below the davit arms, several attempts had to be made by the lifeboat crew before the davit suspension links were finally connected to the lifeboat hooks. Once engaged, the hooks were checked by the C/O, who then instructed the crew to connect the Fall Preventer Devices (FPD)* (**FIGURE 3**) to the forward and aft hooks. After both FPDs had been secured the lifeboat was lifted from the water, though some of the lifeboat crew were not convinced that the hooks had been correctly reset.

*The FPD comprised a synthetic sling with a shackle at each end, which was connected between the suspension link and the hook maintenance shackle of the forward and aft hook assemblies.

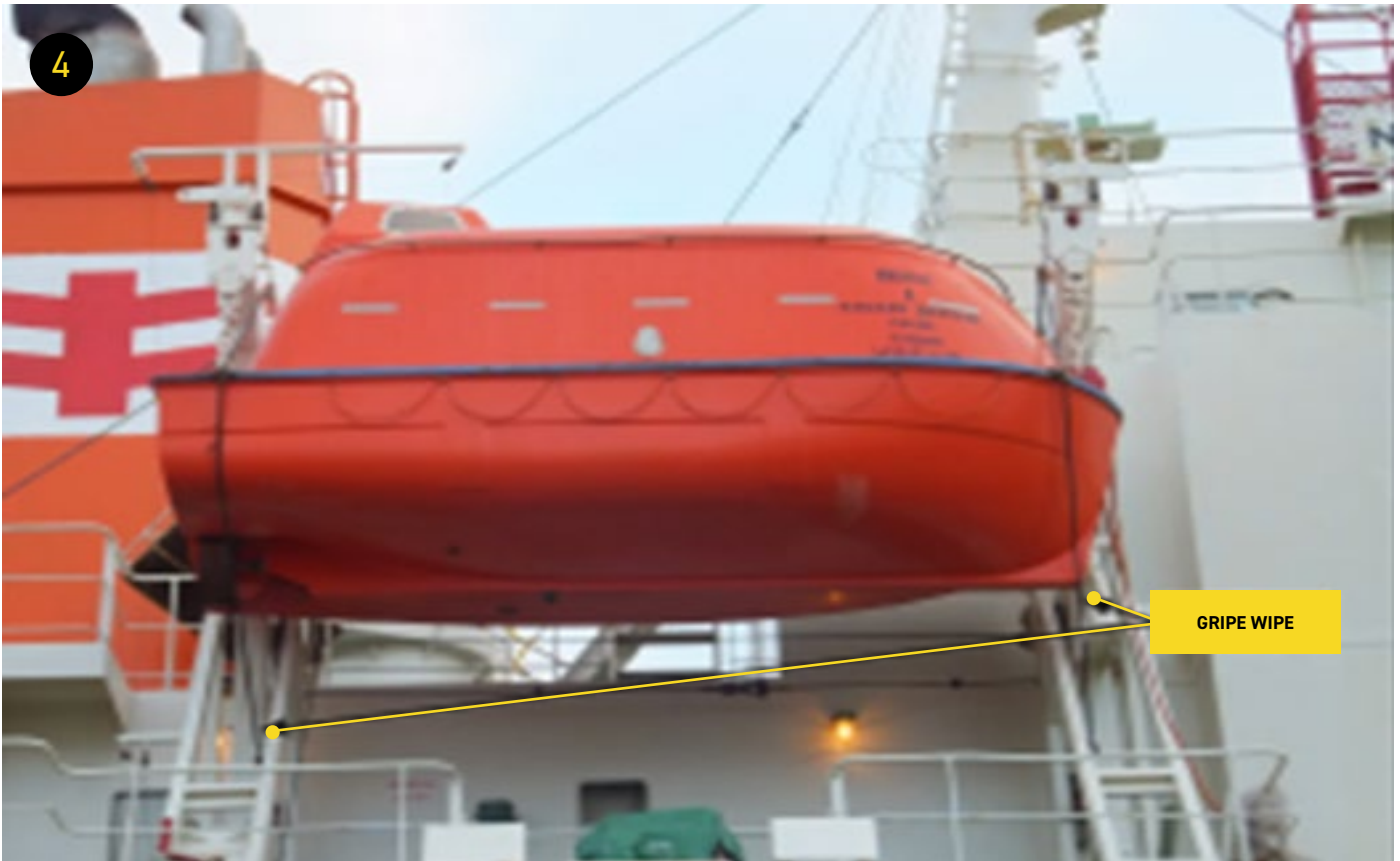
FIGURE 4 GRIPE WIRES (ON STARBOARD LIFEBOAT)
SOURCE MARITIME ACCIDENT INVESTIGATION BRANCH

After the break the C/O instructed the ship's bosun and two crewmen to secure the lifeboat. The two crewmen boarded the lifeboat to assist in positioning the gripe wires forward and aft. The bosun instructed the men in the boat not to release the FPDs until he had connected the gripes to the davit arms (**FIGURE 4**). The aft gripe had been secured and the bosun was connecting the forward gripe when the C/O came to the lifeboat and instructed the men in the boat to release both FPDs. As soon as the forward FPD shackle pin was removed, the hook opened and the forward end of the boat fell onto the handrails on the deck below (**FIGURE 4**), striking and injuring the bosun as it fell.
