FATAL FALL ONTO THE CARGO HOLD TANK TOP

A BULK CARRIER WAS TO CARRY OUT CARGO HOLD CLEANING WHILE DRIFTING IN PREPARATION FOR ITS NEXT CARGO WITH THE HELP OF A RIDING TEAM CONTRACTED FROM ASHORE. DURING THE THIRD DAY OF WASHING THE CARGO HOLDS, ONE OF THE RIDING TEAM MEMBERS FELL APPROXIMATELY 17 METRES (FIGURE 1) DOWN INTO CARGO HOLD NO. 5 AND WAS FOUND MOTIONLESS ON THE TANK TOP. THE PERSON WAS LATER PRONOUNCED DEAD.

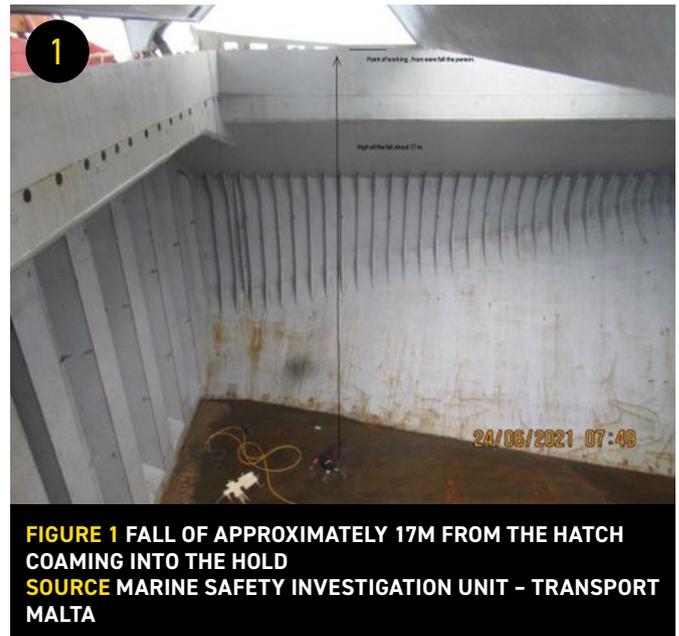
FIGURE 1 FALL OF APPROXIMATELY 17M FROM THE HATCH COAMING INTO THE HOLD
SOURCE MARINE SAFETY INVESTIGATION UNIT - TRANSPORT MALTA

- Proper safety barriers, like safety lines, should be rigged across opened hatches.
- The lack of manpower planning, along with the pandemic restrictions and desire to complete multiple tasks simultaneously, probably led to absence of formal supervision of the riding team.

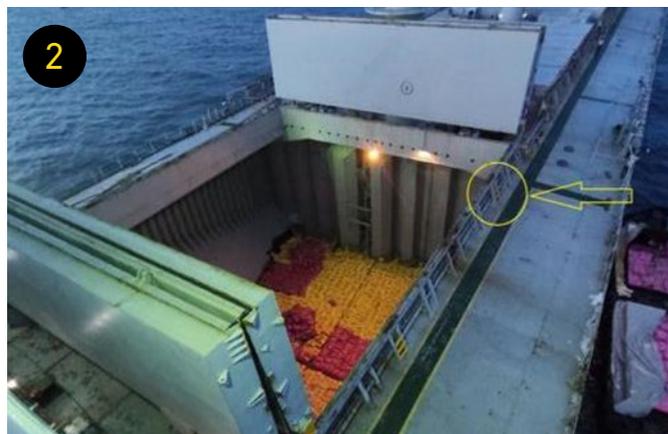
Shortly after, a member of the riding team, who had last been seen standing on the starboard coaming ladder (FIGURE 2) at cargo hold no. 5, fell into the cargo hold from the top of its hatch coaming (FIGURE 3). The water lance he had used for cleaning was later found lying on deck next to where he was last observed standing (FIGURE 4).

FIGURE 2 POSITION INDICATING THE LAST KNOWN STANDING POSITION OF THE DECEASED ON NO. 5 HATCH COAMING LADDER
SOURCE MARINE SAFETY INVESTIGATION UNIT - TRANSPORT MALTA

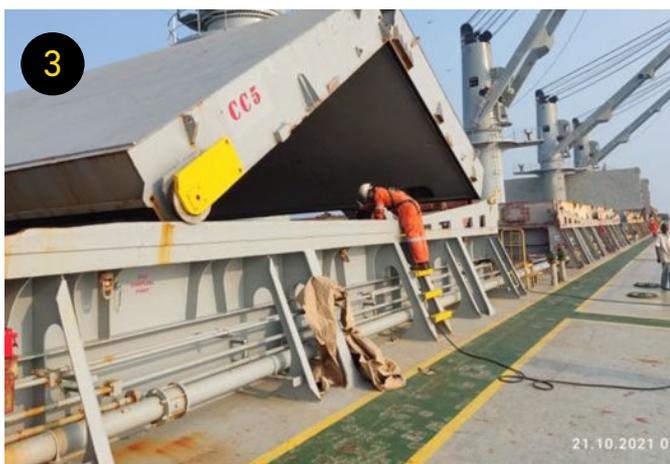
FIGURE 3 LAST KNOWN STANDING POSITION OF THE DECEASED (SIMULATED) ON NO. 5 HATCH COAMING LADDER
SOURCE MARINE SAFETY INVESTIGATION UNIT - TRANSPORT MALTA

- A Permit to Work (PTM) should be completed prior to operation and ensure that all staff are provided with sufficient effective personal protective equipment (PPE) for their assigned job. If the casualty had been wearing proper fall protection, this would likely have prevented the fatality.

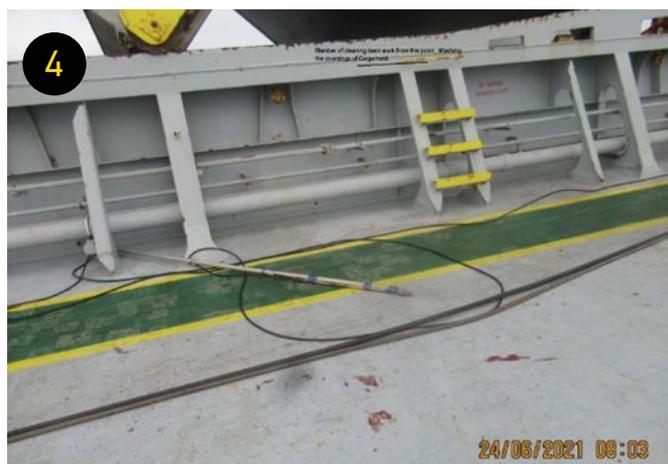
FIGURE 4 EQUIPMENT USED BY DECEASED FOR HOLD CLEANING WAS SEEN LYING ON THE DECK AFTER THE INCIDENT
SOURCE MARINE SAFETY INVESTIGATION UNIT - TRANSPORT MALTA
