IMPROPER USE OF ECDIS LEADS TO GROUNDING

A 43,472 GT BULK CARRIER RAN AGROUND ON A CHARTED SHOAL WHILST ON PASSAGE BETWEEN THE PHILIPPINES AND AUSTRALIA. THE INCIDENT OCCURRED AFTER THE VESSEL DRIFTED FROM THE TRACK, WITH NO AUDIBLE OR VISUAL WARNINGS GIVEN TO THE OFFICER OF THE WATCH (OOW). THE AMENDED PASSAGE PLAN PASSED 0.3NM FROM THE SHOAL WITH THE ELECTRONIC CHART DISPLAY AND INFORMATION SYSTEM (ECDIS) NOT SET UP WITH SUITABLE SAFETY SETTINGS. FOLLOWING THE GROUNDING, THE MASTER WAS ABLE TO EXECUTE THE EMERGENCY RESPONSE ACTIONS AND THE VESSEL WAS LATER REFLOATED WITH THE RISING TIDE, HAVING SUFFERED ONLY SLIGHT DAMAGE TO THE BOTTOM SHELL PLATES.

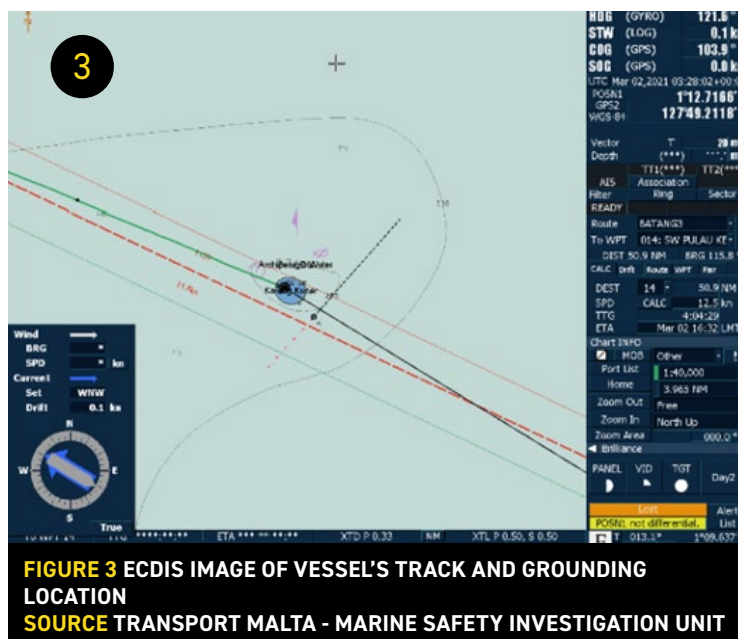
The OOW then began preparing the vessel's pre-arrival documents for the next port, as the vessel began to drift gently. This drift to port was not detected by the OOW and at 1155 the vessel crossed the 5.0m depth contour and ran aground, as shown in **FIGURE 3**. Following the grounding, the master acted quickly to stop the main engine and reported the incident to the owner, before acting as per the vessel's emergency response plan, with tank soundings confirming the vessel's watertight integrity remained intact. The vessel was then deballasted to allow floating on the rising tide.
