DRAGGING ANCHOR LEADING TO MULTIPLE COLLISIONS

A DRAGGING ANCHOR INCIDENT CAUSED A GENERAL CARGO SHIP TO COLLIDE WITH TWO NEARBY SHIPS, RESULTING IN STRUCTURAL DAMAGE TO ALL THREE SHIPS. FORTUNATELY, NO POLLUTION OR LOSS OF LIFE WAS REPORTED.

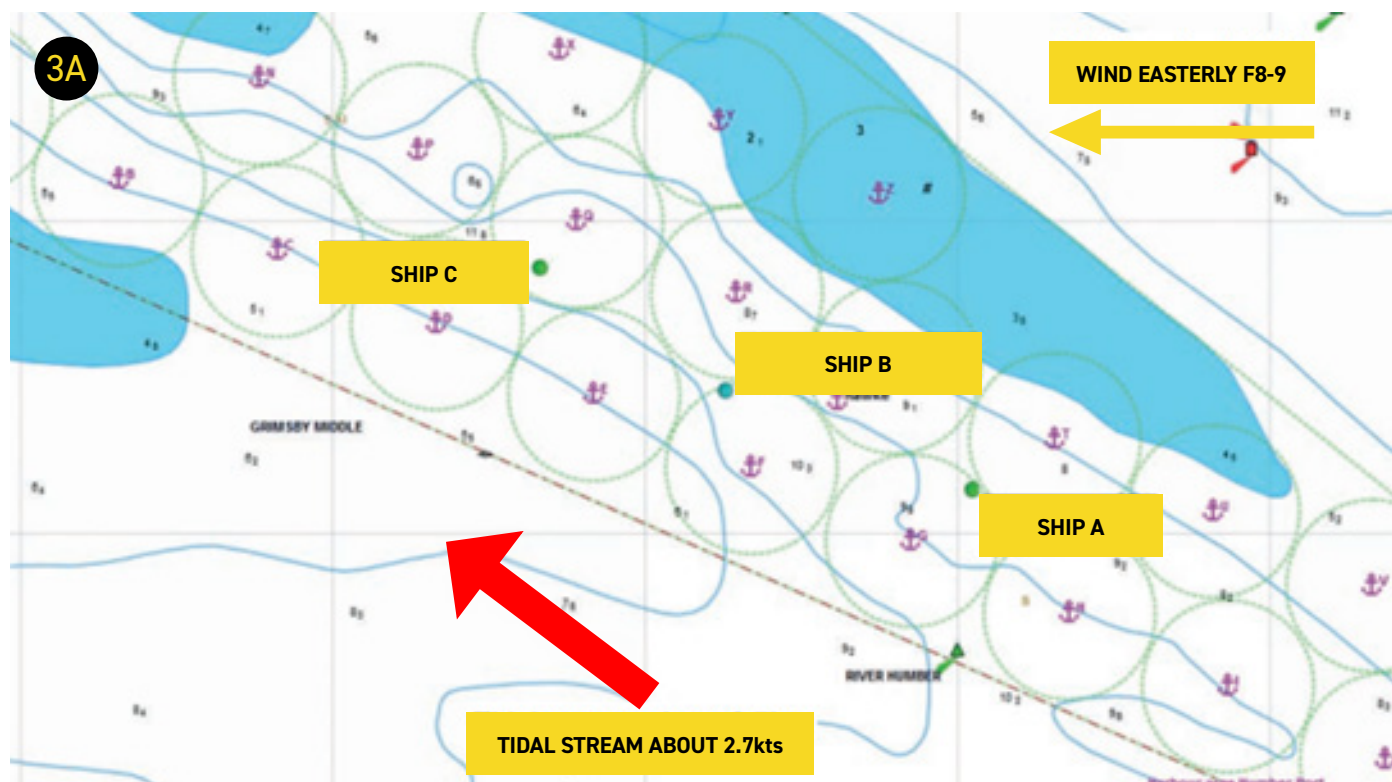
At 02:46, ship A started dragging anchor however, the second officer failed to recognise this until nine minutes later. The second officer notified ship A's master immediately and the duty engineer was called to start the main engine. The duty able seaman was then directed forward to inspect the anchor cable.

FIGURE 3A SHIP A STARTS DRAGGING ITS ANCHOR
SOURCE MAIB REPORT 18/2018

To improve future incident prevention, consider adopting a more frequent and vigilant monitoring interval for anchor positions, along with utilising Global Positioning System (GPS) anchor alarm aids. Implementing a shorter and tighter monitoring schedule could aid in early detection.

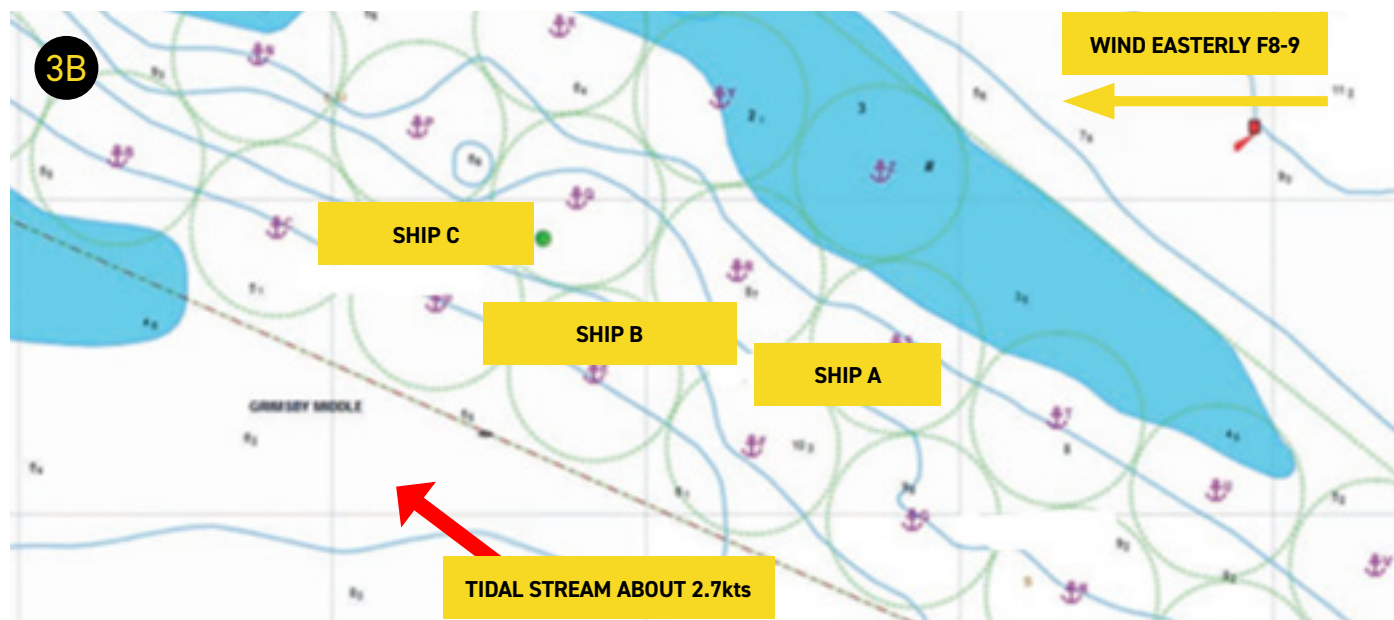
Despite ship A's attempts to start the main engine and utilising its bow thruster for avoidance, the collision occurred at 03:12, with ship A's stern colliding with ship B's bow.

FIGURE 3B SHIP A COLLIDES WITH SHIP B DRAGGING ITS ANCHOR
SOURCE MAIB REPORT 18/2018

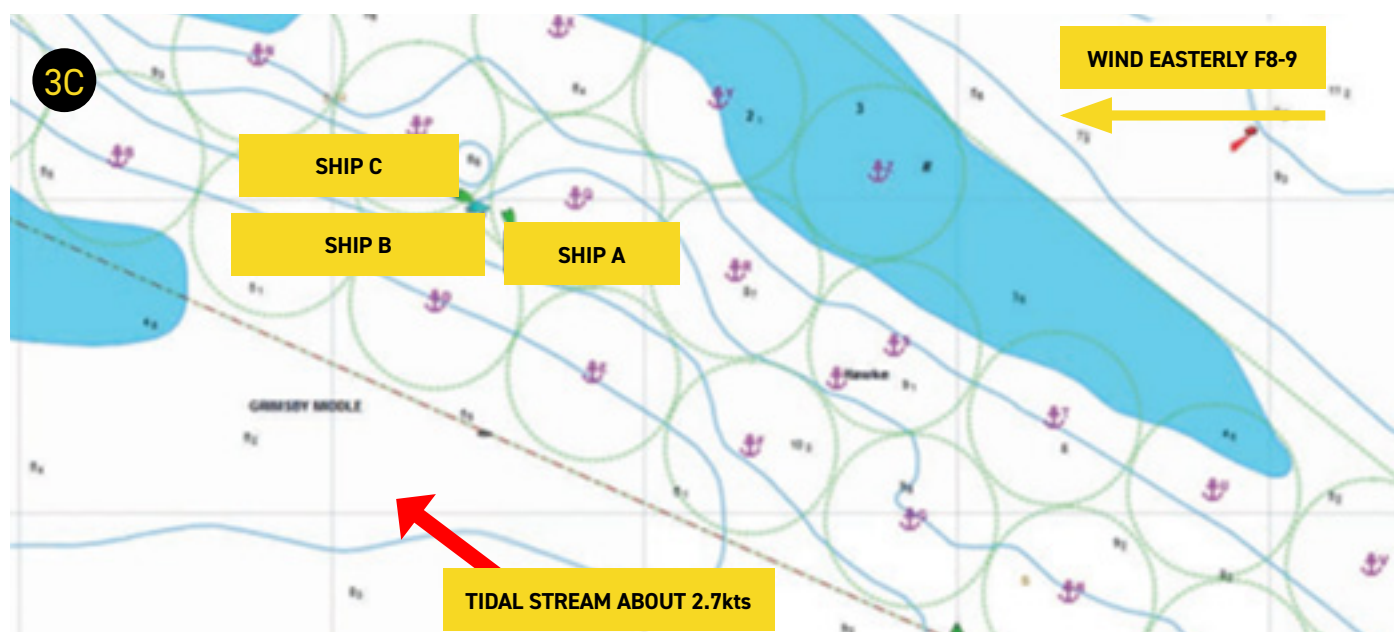
FIGURE 3C SHIP A, SHIP B AND SHIP C DRIFTING AFTER SHIP A'S COLLISION WITH SHIP C
SOURCE MAIB REPORT 18/2018

Ship C was advised by the VTS to weigh its anchor as soon as it became apparent the two ships were unable to arrest their ship's drift. The master of ship C immediately engaged astern propulsion but shortly afterwards, at 03:20, ship A's port quarter collided with ship C's bow.

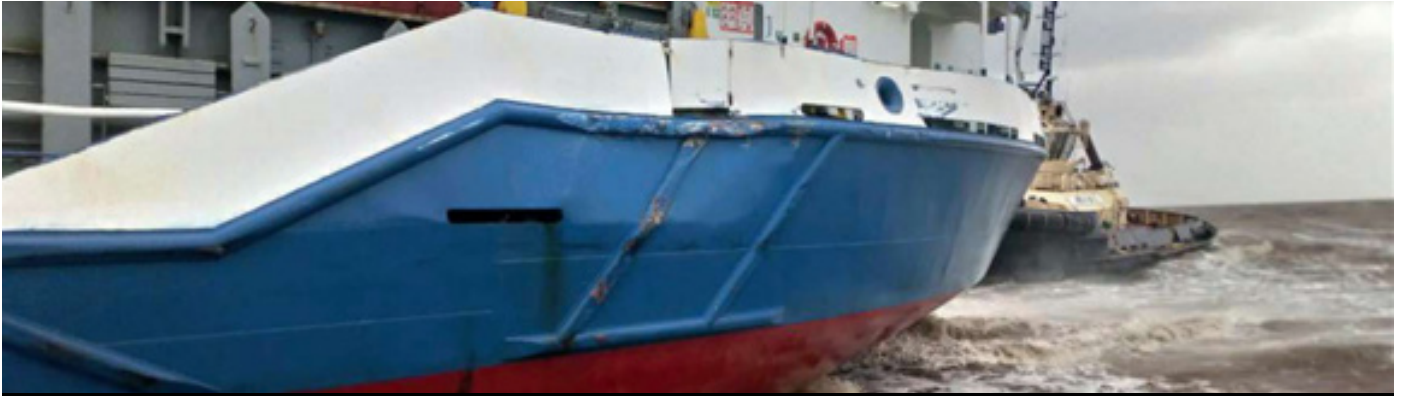
FIGURE 4 SHIP A'S DAMAGE FOLLOWING THE COLLISION
SOURCE MAIB REPORT 18/2018
