B GUIDANCE

DECEMBER 2023

HATCH COVER MAINTENANCE

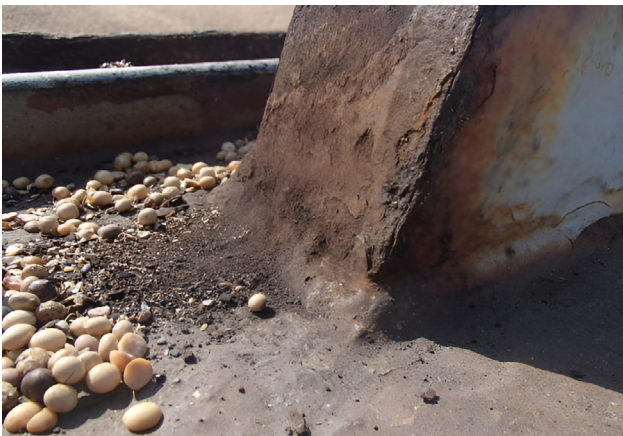
FIGURE 1
Hatch coaming not swept, cargo debris and rust still evident. Centreline joint closing wedge showing severe wear

1. Before closing the hatch covers, ensure that the hatch coamings and double drainage channels are swept clean of any cargo debris. This will ensure that the coaming drain non-return valve remains clear and free as well as ensuring that no damage occurs to either the hatch cover rubber packing or the compression bar. It will also ensure that there is no obstruction to the correct and proper sealing of the hatch cover.

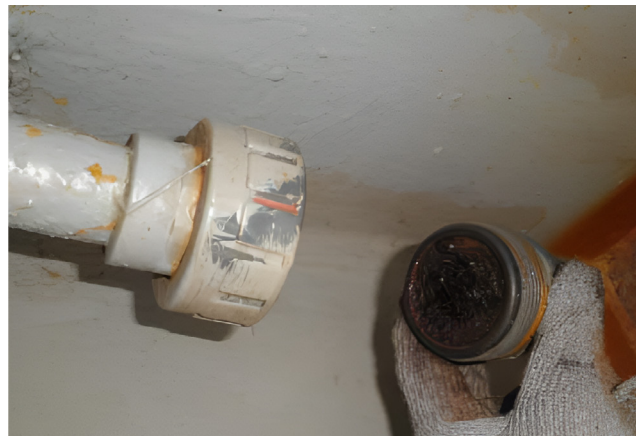
FIGURE 2
Hatch coaming drain completely blocked with debris and rust

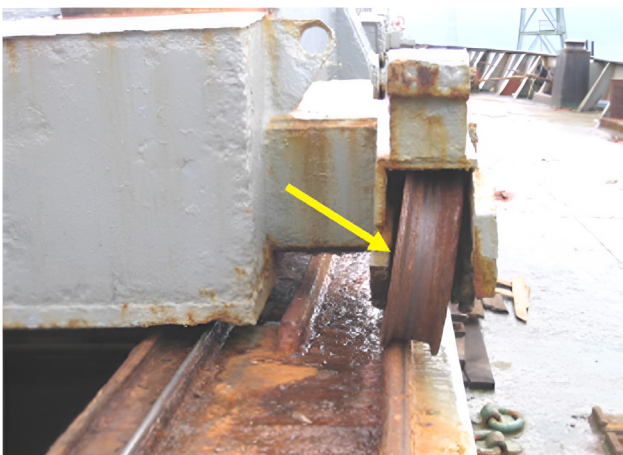
FIGURE 3
Hatch cover guide wheel bearing failed - hatch cover will not close evenly

2. Whilst cleaning, check for any damage to the coaming area, paying particular attention to the compression bars, wheels, wheel tracks and landing pads. Record details of any damages found for urgent or future remedial repairs as required. If temporary repairs are required, it must be ensured that these temporary measures are such that the ship's cargo worthiness will not be affected for the entirety of the voyage. Ensure that the moving parts (wheels, cross joint hinges, hydraulic ram bearings etc. are greased at regular intervals.

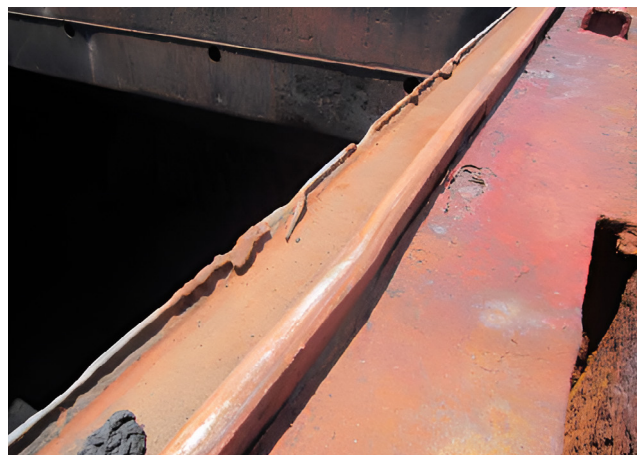
FIGURE 4
Mechanical damage to the compression bar and inner drain channel

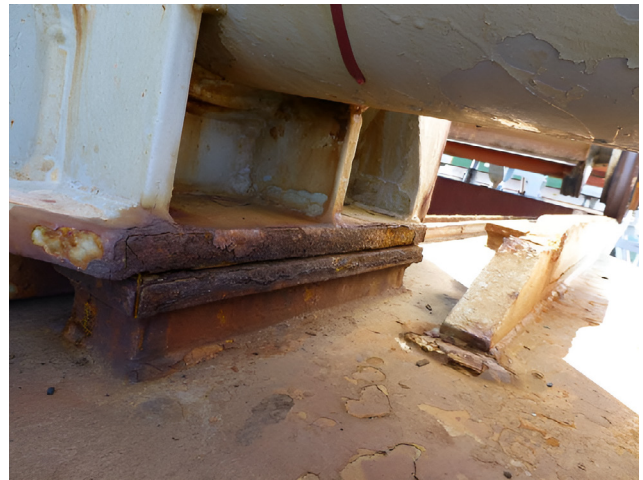
FIGURE 5
Corroded and wasted hatch cover landing pads

3. If the hatch cover design is such that the cover side panels and end plates are in 'steel to steel' contact with the hatch coaming tops when in the closed position, check whether the coaming tops are free from grooving or wear. This would indicate worn hatch sealing rubbers.
4. Hatch cover landing pads should be maintained in a good condition at all times, ensuring that any corrosion is dealt with in a timely manner and that the pads are greased regularly.
5. Grooved, corroded or worn down landing pads are to be either built up with welding and ground back to original dimensions or cropped off and replaced in their entirety.

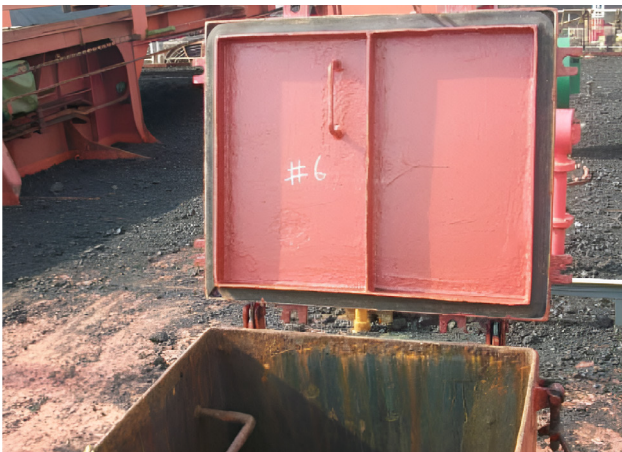
FIGURE 6
Evidence of water ingress at the cargo hold entrance hatch and the hatch coaming

6. Check for any rust streaks on the inside of the coaming which would indicate water ingress from leaking hatch cover seals. Take remedial action and repair the seal and clean off the rust streaks.

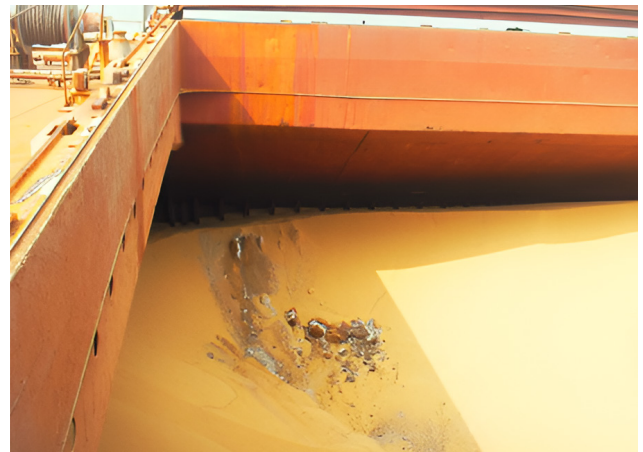
FIGURE 7
Evidence of water ingress at the cargo hold entrance hatch and the hatch coaming

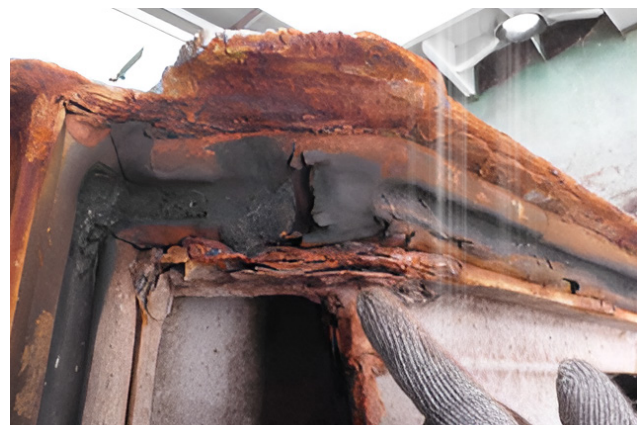
FIGURE 8
Hatch cover sealing rubbers damaged and showing permanent deformation beyond the recommended limits. Rubber seal channels severely corroded.

- 8. When cleaning the seals, check for signs of permanent deformation (a useful general rule is 30% of the seal thickness). If sections of sealing rubber are required to be replaced, the minimum length is 1m. However, it is often better to replace a full length of sealing rubber to ensure effective and even compression.

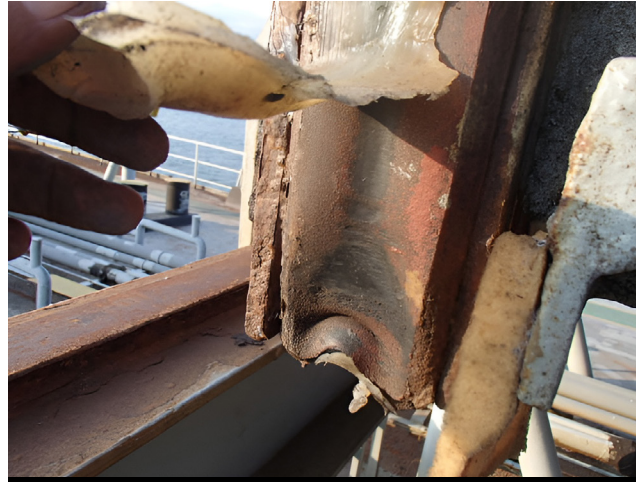
FIGURE 9
Silicone applied in an attempt to effect proper sealing

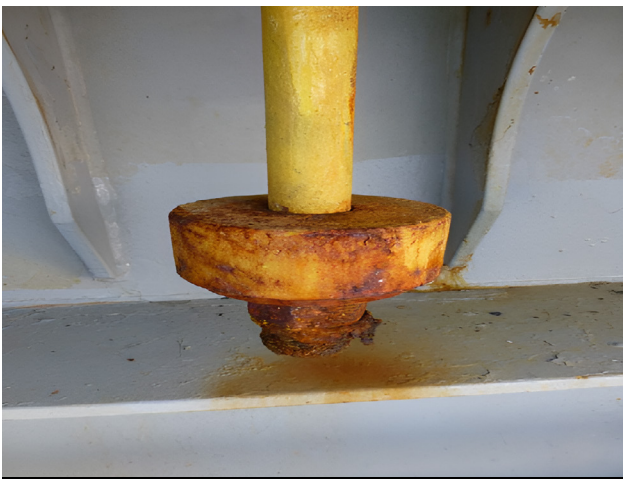
FIGURE 10
Hatch securing cleat, seized and painted over

- 9. Hold access hatches and ventilation covers need to be carefully scrutinised in the same manner as the hatch covers themselves, for signs of damage to the sealing areas, securing arrangements etc.
- 10. The function of the cleats is to keep the hatch covers in position and maintain the seal's design compression. The excessive tightening of cleats will not improve weather tightness but will lead to the accelerated wear of the seals and the landing pads and could even distort the hatch cover. Cleats and their snugs should be inspected for any damage, ensure the rubber washer is intact and not perished and the tightening nut is free to move.

- 11. Standard adjustment of the hatch cleats is to tighten the nut hand tight against the steel washer and then to further tighten by 360 degrees.

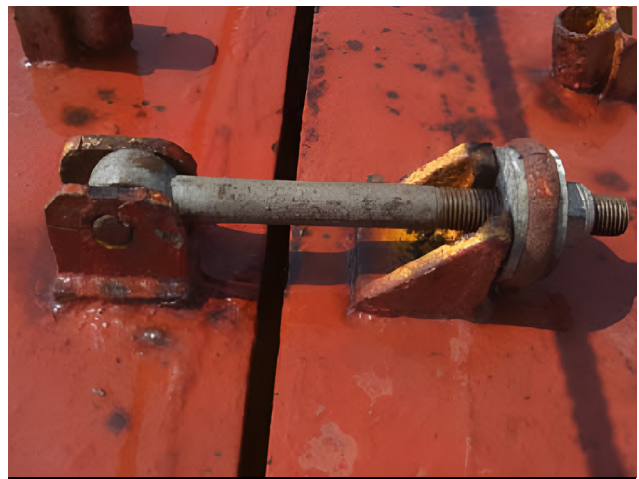
FIGURE 11
Cross joint cleat renewed but old perished rubber still in use

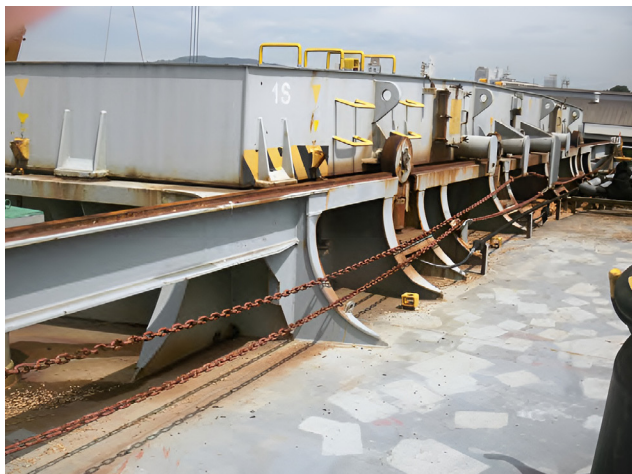
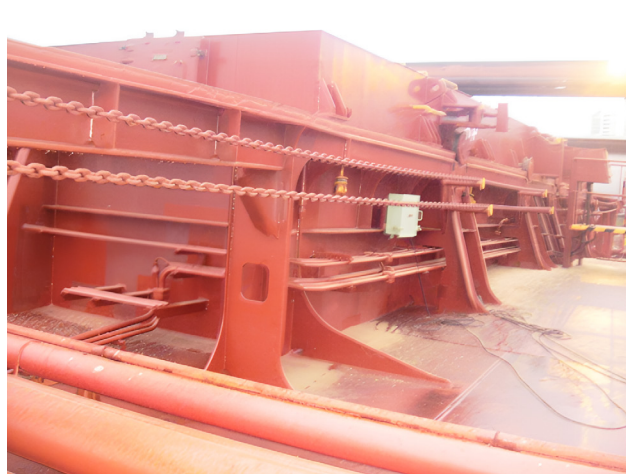
Same class of vessel, same age, two different Owners, can you spot the difference?
