Lone Watchkeeping – Grounding at Night

Lone Watchkeeping – Grounding at Night**BACKGROUND**

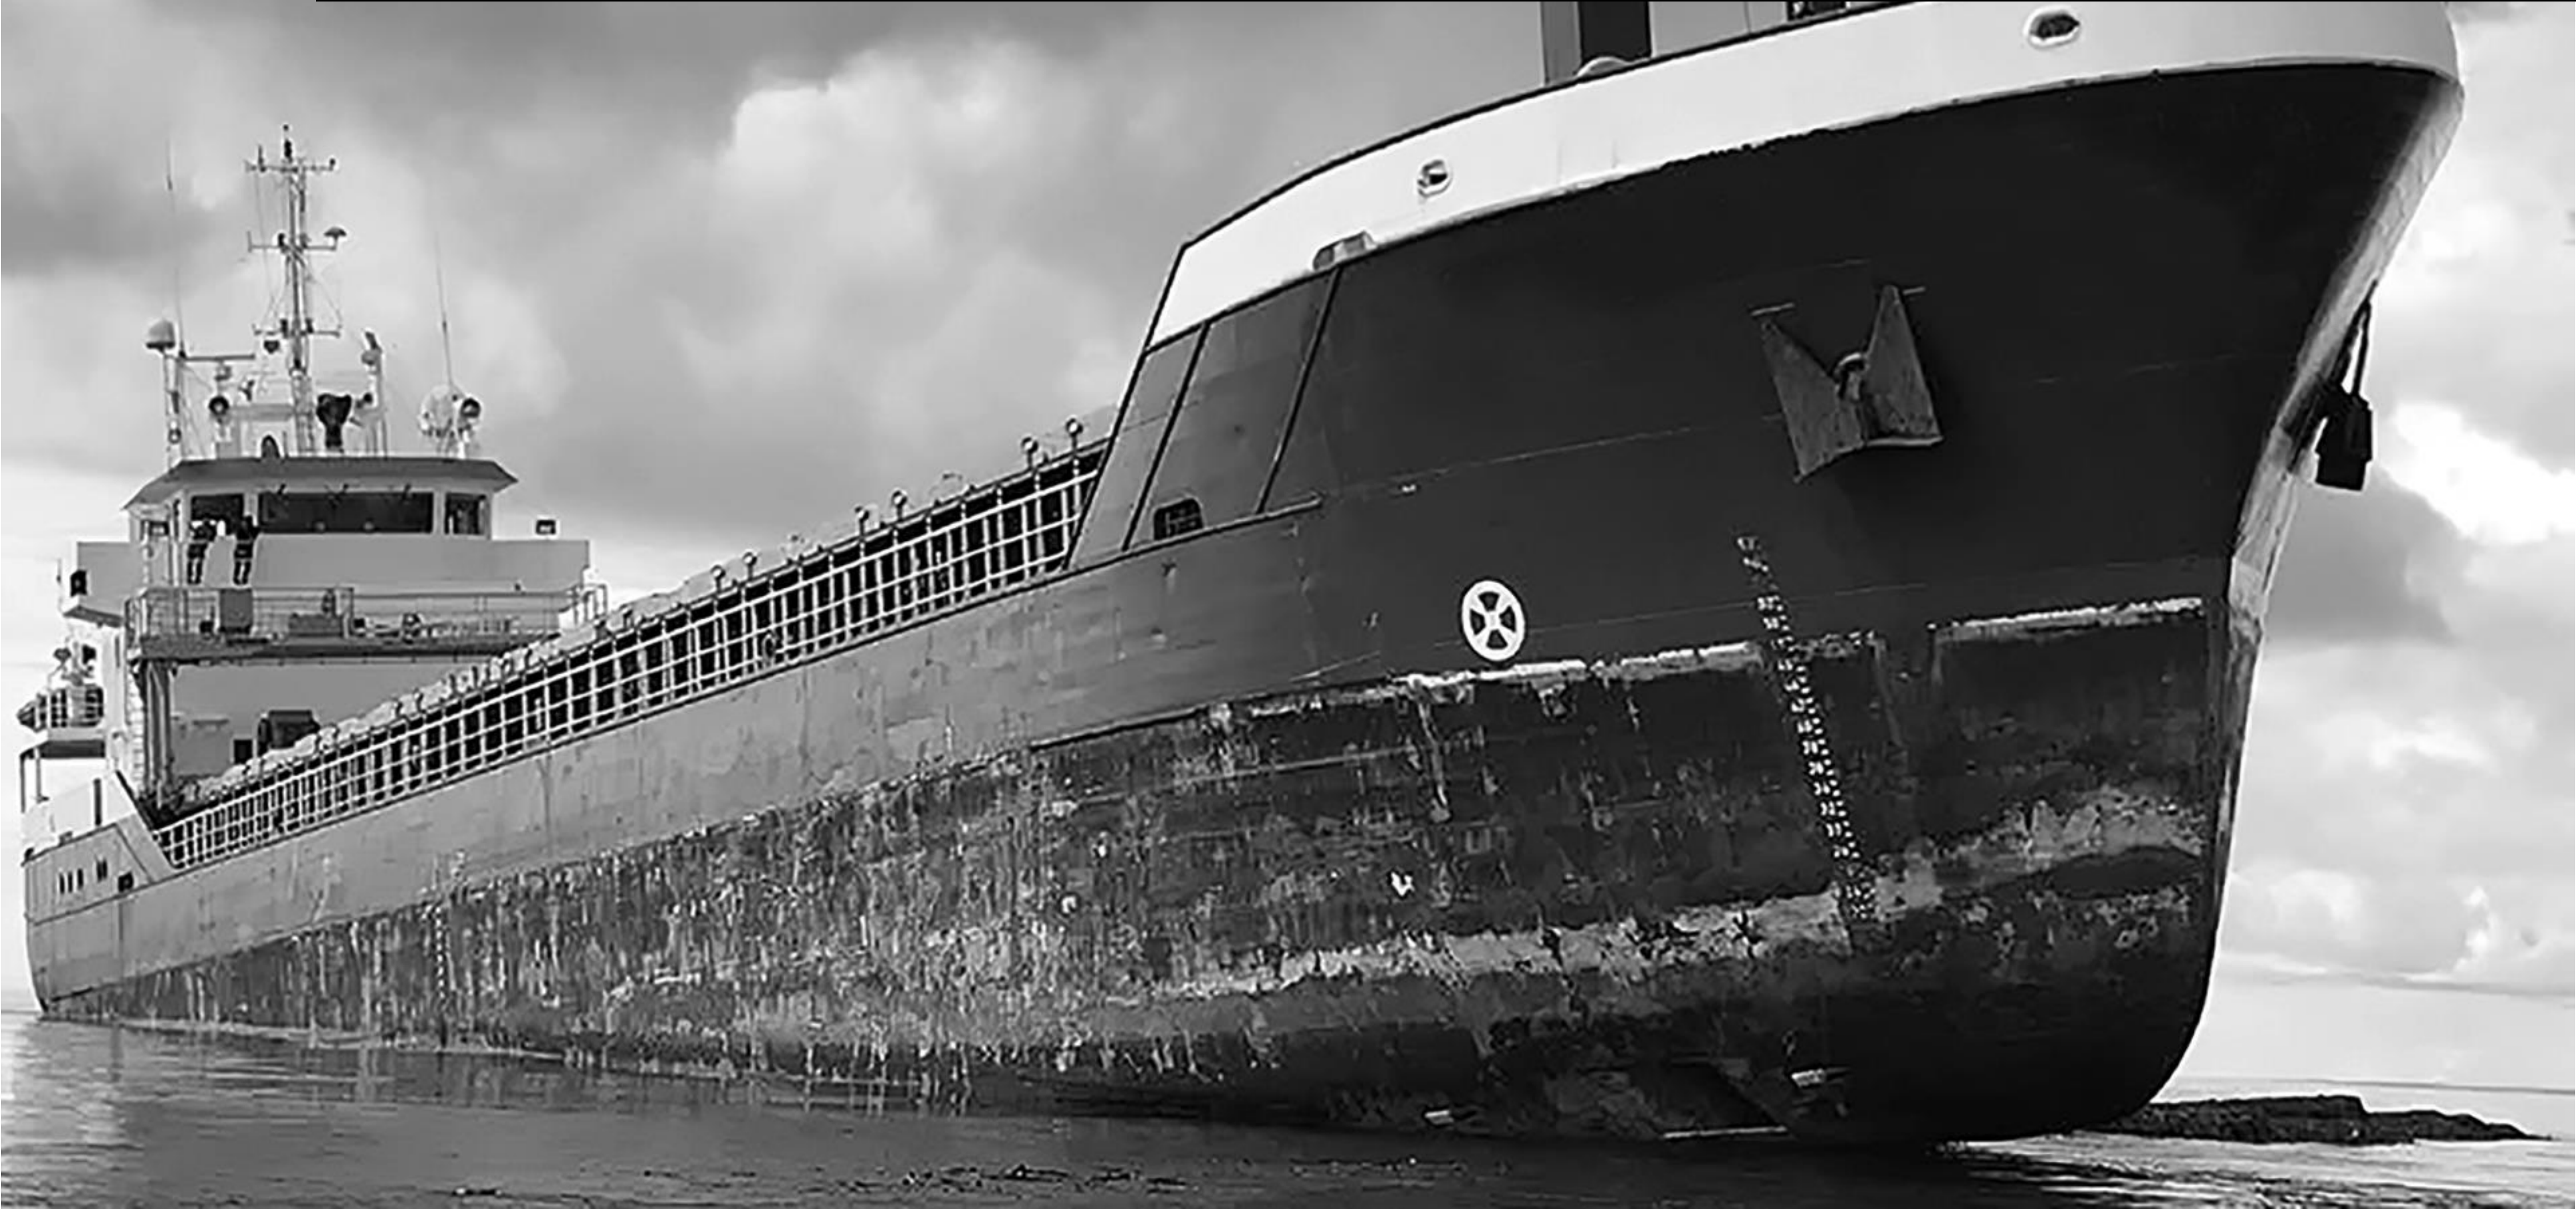
- **A 2281GT General Cargo Ship – was en route from Klaipeda, Lithuania to Silloth, England.**
- **The ship's route was planned north of Scotland transiting the Pentland Firth.**
- **Before transiting Pentland Firth a bridge team meeting was held to discuss the forthcoming passage as it is notorious for extreme tidal and sea conditions.**
- **The Master decided to adjust the bridge watchkeeping schedule in order to make the transit in favourable tidal conditions. The cadet was directed to keep watch from 2300 to 0200, with the transit of the Pentland Firth due to begin at about 0500.**
- **At 0200 a Maritime officer had taken over the watch (OOW), he decided to deselected track mode steering and switched to autopilot.**
- **He then sat down in the bridge chair watching music videos on his mobile phone.**
- **The Bridge Navigation Watch Alarm System (BNWAS) was not activated.**

- At about 0443 the ship grounded on Pentland Skerries at a speed of 7 knots.

- The ship sustained extensive damage to its hull.
- Unable to be refloated until seven days after the incident.

- **Risk assessment** – An effective risk assessment taking into account the proximity of navigational hazards while operating at night would have identified the need to retain an additional lookout.
