RISK WATCH

TRW

JUNE 2018

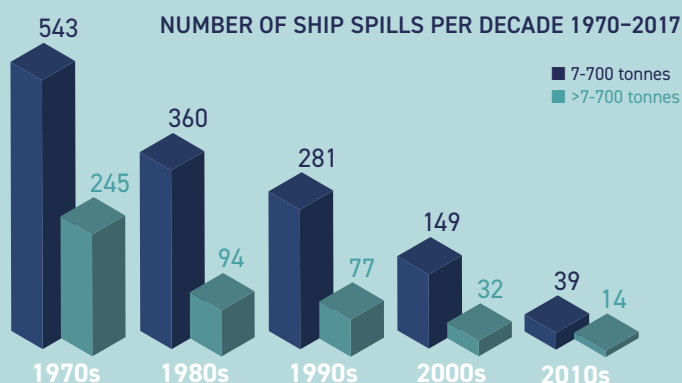
ITOPF has published details of small spills (defined as less than 7 tonnes) medium sized spills (defined as 7-700 tonnes) and large spills (over 700 tonnes) for each year from 1970 to 2017. In order to identify global trends, an average figure has been calculated for each decade and is illustrated in the graph below.

In the 1970s there were on average 54.3 medium sized oil spills and 24.5 large oil spills per year. In the 1980s the average annual number of spills had fallen significantly to 36 medium sized spills and 9.4 large spills. This downward trend has continued in each decade since. From 2010, the average annual number of oil spills has fallen to an all-time low of 4.9 medium spills and 1.8 large spills. These reductions have been mirrored by the quantity of oil spilt at sea and comes despite the global growth in the quantity of oil carried by ships over the period.
